# A Failure Analysis of the Exhaust Valve of EMD Locomotive Engine

Rushikesh Kumbhar<sup>1</sup>, Sumant Kandalkar<sup>2</sup>, Dhanaya Kulkarni<sup>3</sup>, Bharat Jejurkar<sup>4</sup>

<sup>1, 2, 3, 4</sup> Students, Department of Mechanical Engineering, AISSMS COE, PUNE, INDIA

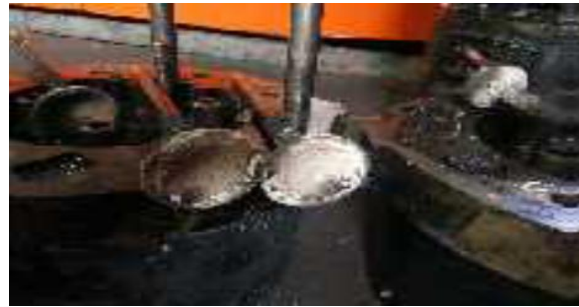
The scale formations are on the valve which corrodes the surface of valve due to exhaust flue gases. Surface material is removed in service life and it is the result of erosion by small, solid, impacting particles. In most elevated - temperature erosion environments, the eroding surface is undergoing corrosion as well as erosion. Hot gases escaping at seat of an adjacent valve are directed at shot-blasted fillet area and erode surface material. Valve guttering generally occurs because of flow of exhaust gas across the valve face surface, resulting in the formation of a radial channel or gutter. Typical causes of gas leakage include valve distortion, face pinning and degradation of face deposits.

Figure: Corrosion on Valve

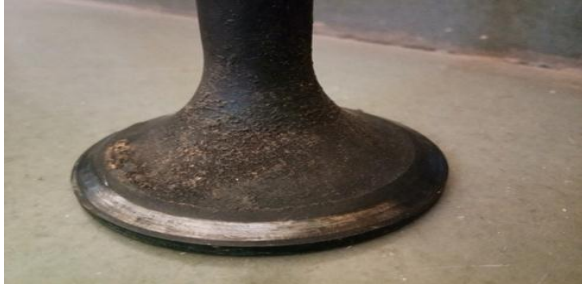
Figure: Valve Face Wear

The origin of valve face wear is improper valve spring tension, high speed and excessive heat, loose valve adjustment, and excessive abrasive dirt in intake. Continue operation with this type of wear leads to cupping. It is theorized that “initial” valve face wear rate is greater than the rate of wear after break in, under normal condition.

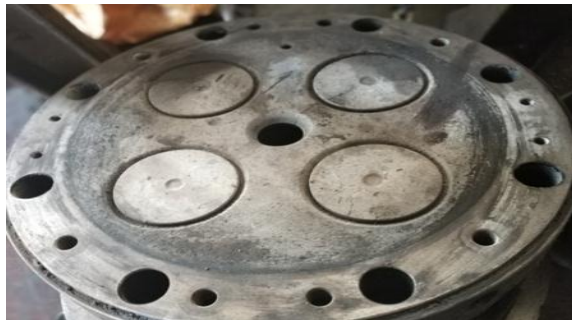
Studies have shown that the exhaust valve seat wear mainly involves two distinct mechanisms. The first one is the impact of valve on the seat as it closes and second mechanism is Micro-sliding, caused by the elastic deformation at the valve seat interface as the valve head is pressed into its seat by the high combustion pressure. Experimental work performed also show that combustion load, valve misalignment and most importantly, the valve closing velocity have a significant effect on valve face recession

Figure: Valve Seat Wear Due to cyclic loading

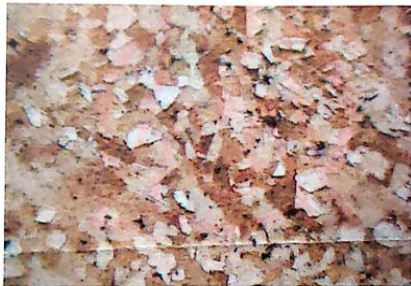
Figure: Microstructure Test

MICRO EXAMINATION:-  
Test Method : Reference ASM Vol. 9  
Magnification :- 200X Etchant :- HCLHNO3

Observation :-  
It consists of equivalent extent of Nickel solid solution matrix & austenite. It Shows Fully annealed equiaxed grain microstructure, (Grain Boundry Structure).  
Grain Size is ASTM NO 5-7.

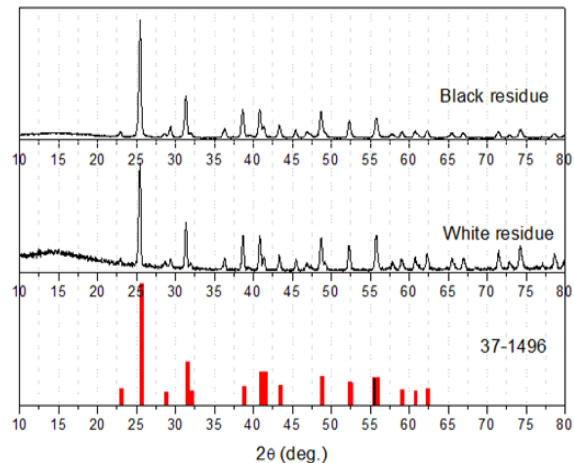
Figure: X-Ray Diffraction test result

In visual inspection test we identify residual powder settlement on stem, neck and face of valve. Due to accumulation of these residual powder heat dissipation is hindered on neck and stem area. On face white residual powder is accumulated due to combustion of fuel. On stem and neck black residual powder is accumulated due to incomplete combustion and possibility of burning of lubrication oil. If lubrication oil is burnt then it is of serious concern. For these we did XRD test to compare white residual and black residual sample. XRD is used to identify single crystal, to reveal the structure of single crystal. It is used for phase detection and provides information on unit cell dimensions. The X-rays are generated by cathode ray tube directed towards the sample. The interaction of incident rays with sample produces constructive interference when conditions satisfy Bragg's law. As on exhaust valve two types of residue formation was seen. The above graph shows the XRD results of both the residues named as black residue and white residue. Black residue was formed on stem part of the valve and white residue was formed on the valve base portion. As on valve these residues may be formed due to reasons like incomplete combustion, mixing of lube oil, etc. To know the presence of different elements in these residues, XRD analysis was conducted i.e. to check the purity of the sample.
