Unforeseen ground conditions met in North Bound Tunnel (TBM - Rudra) in Tunnelling Work and solution found, Remedial measures Implemented – Case study

RUPA PARAMANIK BANERJEE¹, PROF DR. SANDEEP POTNIS², SUBRAHMANYA GUDGE³

³ Bangalore Metro Rail Corporation Ltd. Bengaluru, India

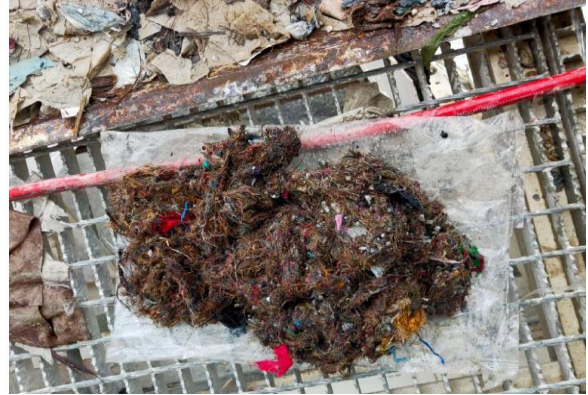
Fig. 3

Soil investigation carried out beyond location of TBM stopped due to repeated formation of sink holes revealed that soil beneath the ground contained blackish waste (Fig. 3, 4) indicating the presence of deposition of city waste. Such material was not found in any of the soil investigation locations considered while detailed investigation before tendering process. The Geophysical survey was also carried out in the area (from Chainage 8+940 to 9+340m) along Bannerghatta road. Report on such survey is placed as Annexure A. As may be seen from the report, the investigation did not detect artificial materials.

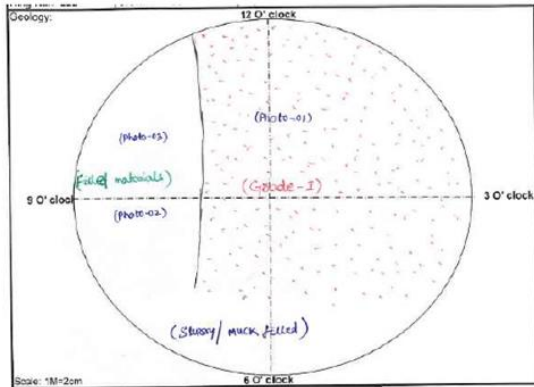
Face Mapping data of Ring No. 695

Geological mapping of excavated face in this zone indicated the partial exposure of poor geological condition with debris/garbage. Additional drillings dynamic cone penetration tests were also carried out for further investigation.

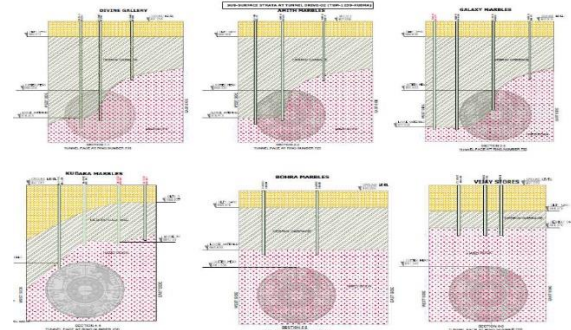
Fig. 7

Several DCPT probes were drilled along the alignment and different cross sections were plotted with respect to the rock levels found in each probe, the section on each building with rock profile shown below: (Fig. 6,7,8)

Geological Cross Sections ahead of TBM 1259

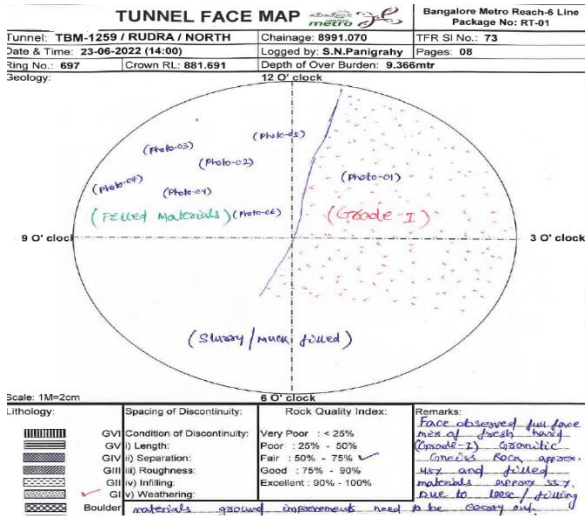
Fig. 9

The investigation revealed that 75% of the tunnel face on East side is in rock and balance 25% on West side is filled with manmade materials. (Fig. 9) All the borelogs of the DCPT tests are available in Annexure C.

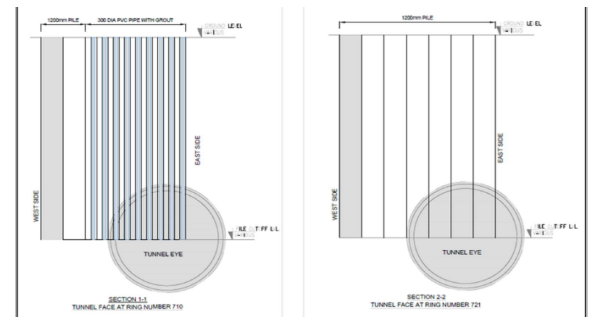
Fig. 10

Cross Section of the Proposed Ground Improvement

The cantilever behavior accordingly the detailed plan of ground improvement shown below (Fig. 10):

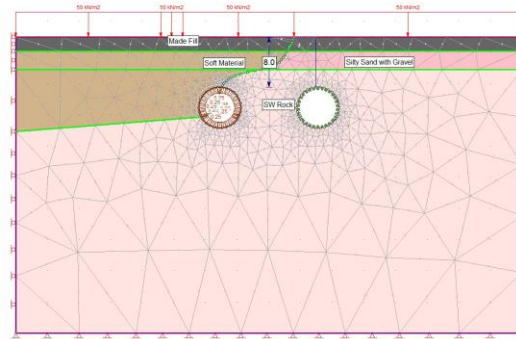
Tunnel excavation in actual ground condition
Fig. 11

FEM results showed excessive settlements more than 150mm due to the debris/garbage without ground improvement. Soft pile block of 1200 dia with M10 concrete from CH.9000 TO CH.9050 was proposed, the outer most row of piles were socketed to minimum depth of 300mm in grade I/II rock to obtain the cantilever behavior of pile and casting retained for additional stability.

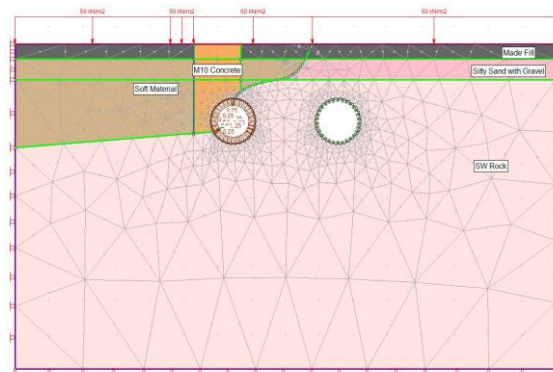
Tunnel excavation after ground improvement
Fig. 12

FEM results after the ground replacement shows negligible surface settlement values of less than 6.5mm and surface settlement values are less than 2mm away from the ground improvement zone.

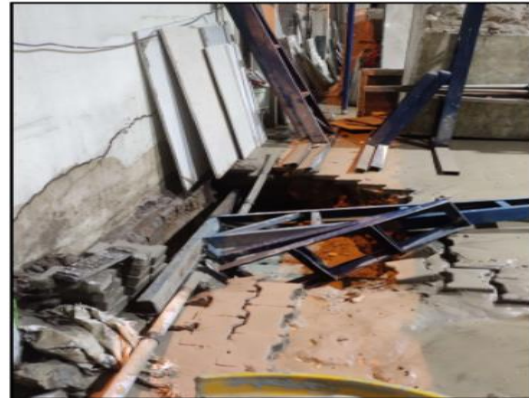
• Sink Hole occurred at "Paramount Marble Shop" on 20 July 2022 03:16 am at CH:8992.520m. (TBM S1259)

Fig. 13 Showing Sink hole at Paramount Marbel shop

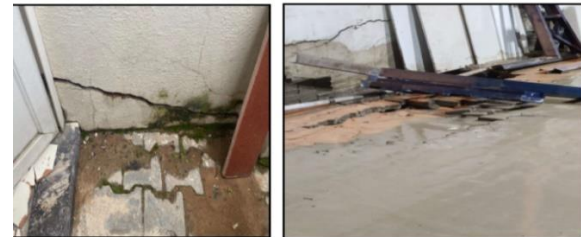
Fig. 14 Showing cracks on Paramount shop

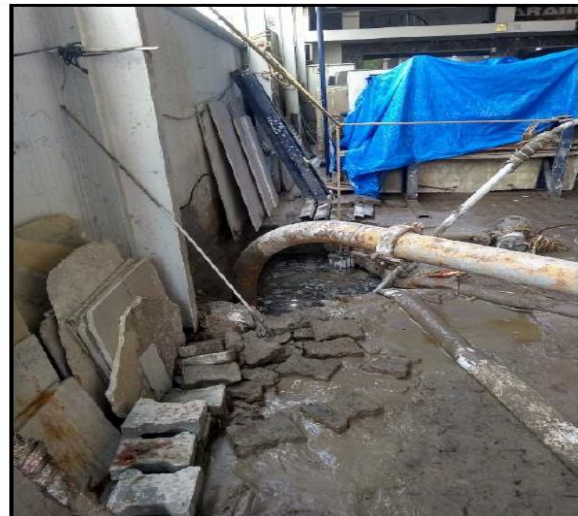
Fig. 15: Showing grouting is under progress

- Grouting (450kg Cement:700Ltr Water) was done on 20th July 2022.

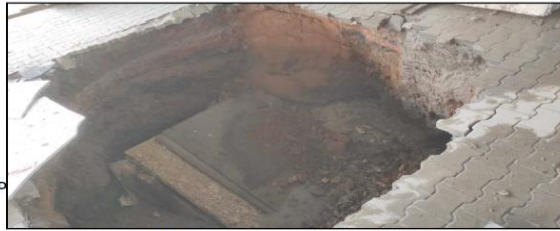
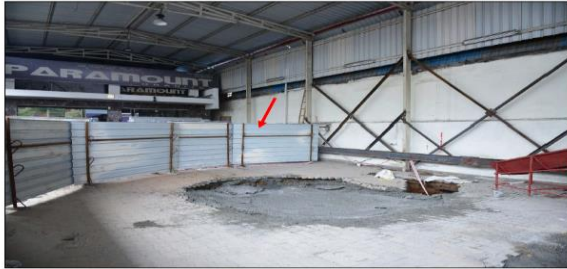
Fig. 16: Showing temporary arrangement near sink hole location

- Hard Barricade (10 nos.) provided at Sinkhole location for protection.
- Cross bracing column supports also provided at Paramount Shop.

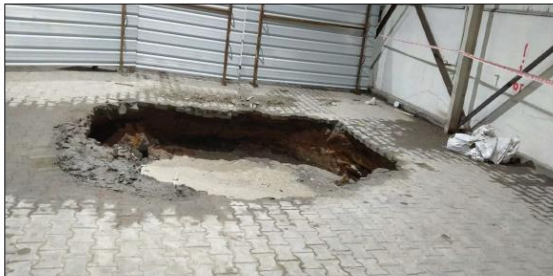
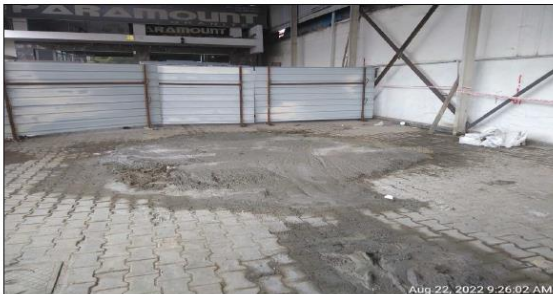
- Sinkhole occurred at same location at Paramount Marble Shop (Ring 708-710 location)
- M20 Concrete: 6 cum, Slurry: 18 cum, Sodium Silicate: 200kg.

Fig. 17: Showing grouting work at sink hole location

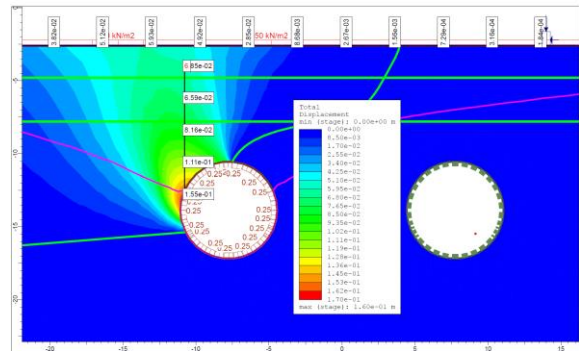
Showing total Displacement at final stage (Case 1)

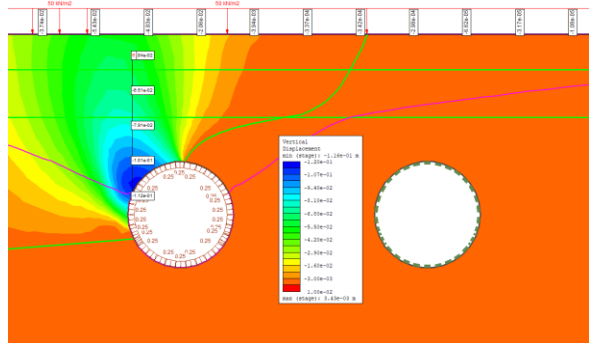
Showing vertical displacement at final stage (Case 1)

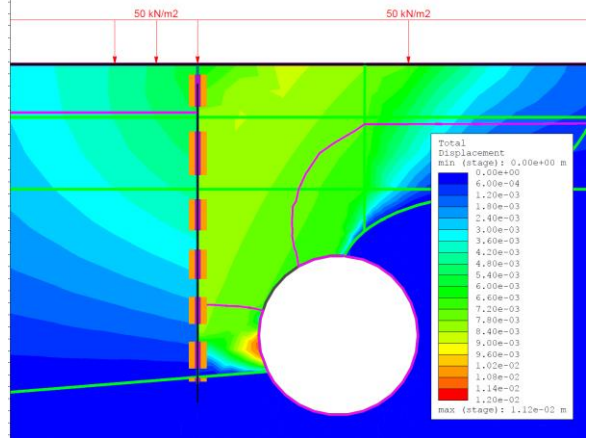
Showing Total Displacement at final stage (Case 2)

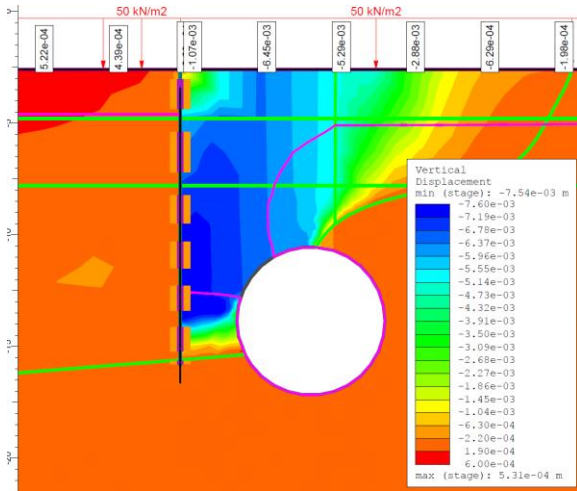
Showing Vertical Displacement at final stage (Case 2)
