Efforts to Create Walkable Junction by Analysing Factors Intimidating Pedestrian Conveyance at Uncontrolled Junction

Varsha Nair¹, Reema Kuntmal²

^{1,2}*Indus Institute of Technology and Engineering (IITE), Indus University, Ahmedabad*

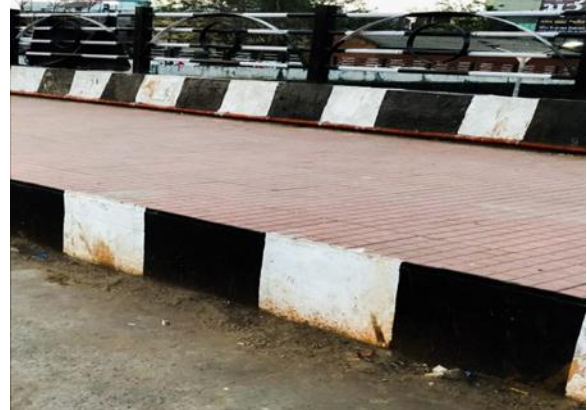
Figure 2 Inadequate height of footpath

1. Traffic conditions have been studied and were observed to be slightly heterogeneous in nature without following required lane disciplines.
2. No proper and visible road markings.
3. Illegitimate height of the footpath at the intersection.
4. Congestion due to stopping and waiting of shuttle vehicles leading to loss of public space.
5. Uncontrolled, un-signalized and poor planning of crossroad leading to indecision.
6. High count of the pedestrian flow has been witnessed as the area lies in the heart of the city.

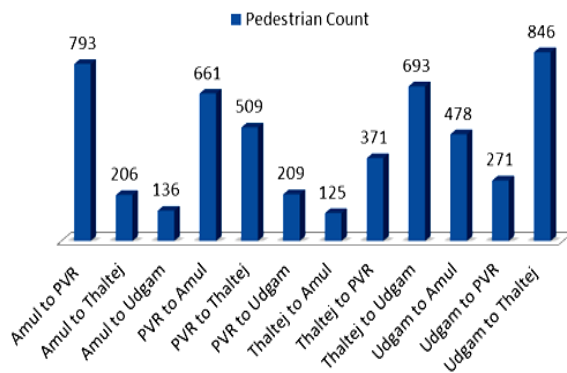
Figure 8 Direction-wise chart of pedestrian count

With respect to the directions, it has been observed that pedestrians had 3 alternate routes for each of the destinations, across the junction. A good count of pedestrians was observed taking straight path among that the moment across Udgam to Thaltej had a crown value of 847 people, followed by Amul to PVR, Thaltej to Udgam and PVR to Amul having a
