Evaluation and Maintenance Priority for the Low Volume Flexible Pavements

Abstract The maintenance of roads is critical for ensuring safe and efficient transportation. In particular, low volume roads, which have lower traffic volumes than highways and major roads, are often neglected in terms of maintenance. However, even though they may not experience heavy traffic, low volume roads are still susceptible to failures and defects that can compromise their integrity and safety. In the Nagpur region, there are many low volume roads that are in need of maintenance. In order to ensure that these roads are properly maintained, it is important to study the failures and defects that are present on them, as well as their possible causes. By identifying the root causes of these issues, it is possible to develop effective maintenance strategies that prioritize repairs based on severity and current condition. Some common causes of failures and defects on low volume roads include poor drainage, inadequate road construction, and heavy vehicle traffic. These issues can result in cracks, potholes, and other damage that can cause safety hazards. By conducting regular inspections of these roads, it

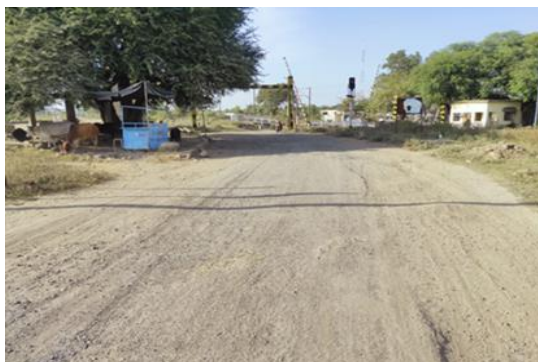
Figure 1: Godhani Road Patch 1

During our visit to the first 500m road patch, our team conducted a comprehensive visual inspection of the pavement, diligently documenting all observed

defects. To ensure accuracy, we divided this section into five equal parts of 100m each, labeled as A, B, C, D, and E. For each section, we meticulously recorded

the different types of pavement failures encountered, noting precise measurements such as length, width, and depth.

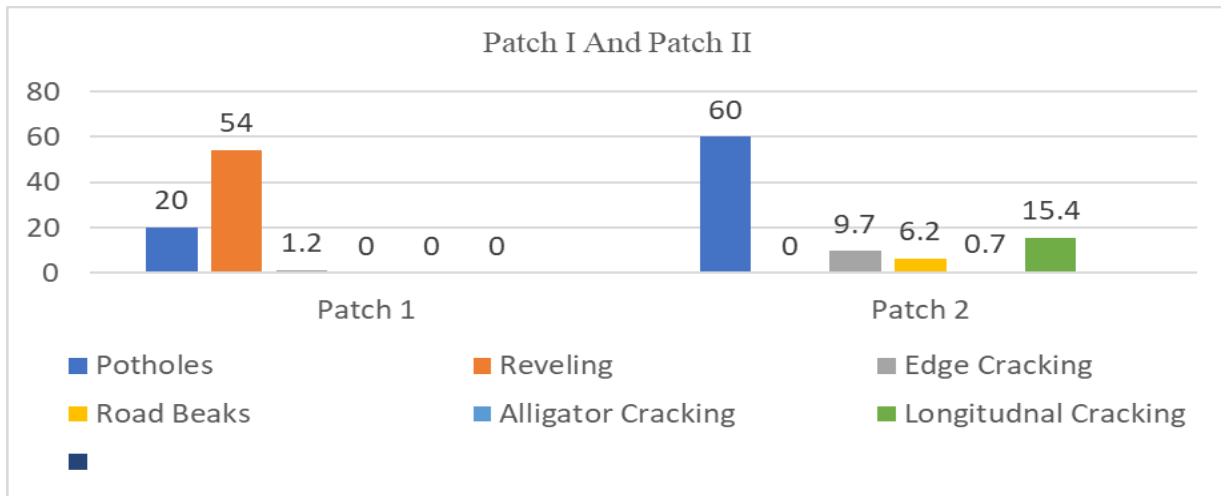
Graph 1: Distresses Percentage in Godhani road

The distress quantity and coverage area were assessed to determine the extent of damage. By comparing this area to the total damaged area of the pavement sections, the distress percentage can be calculated.

Below graph illustrates the distribution of measured distresses as a percentage of the overall failed pavement area.
