Analysis And Strengthening of Distressed Structural Members of A Building– Case Study

Index Terms: E-Tabs, Numerical Modelling, Concrete Jacketing, Epoxy Grouting, Micro-concreting

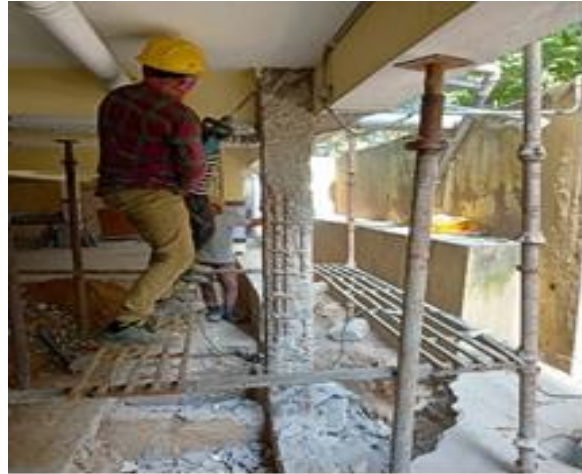
Figure-5 : Chipping of concrete

- All the loose, spalled concrete of the existing column is chipped off as shown in figure.5.
- The exposed corroded reinforcement was cleaned using wire brush to remove the rusted portion and then treated using zinc-rich anti-corrosive paint.
- Additional vertical reinforcement anchored and stirrups were fixed at regular spacings and binded to the shear connectors shown in Figure.6.

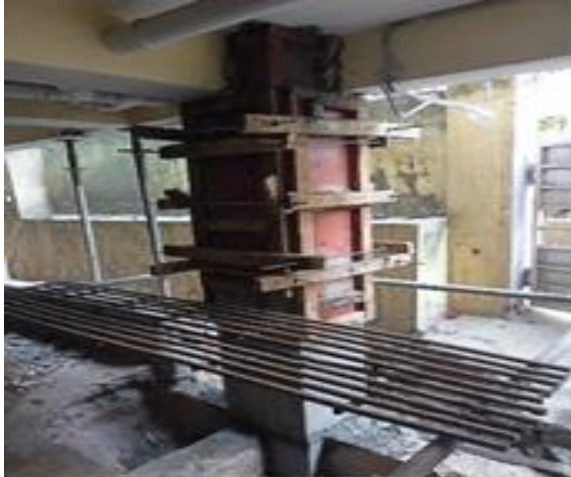
Figure-7: Shuttering

- After fixing additional reinforcement & shuttering is done as shown in figure.7, concreting using high grade, non-shrink, free-flow micro concrete added with 12mm down aggregate at the specified ratio as per manufacture specification of micro concrete material was carried out to encase the existing distressed column.
