# Study of cracks on Rigid Pavement resting on Black Cotton Soil through Paithan Case Study

Tushar D. Ukirde<sup>1</sup>, Santosh B. Kapse<sup>2</sup>

<sup>1,2</sup>Deogiri Institute of Engineering and Management Studies, Aurangabad

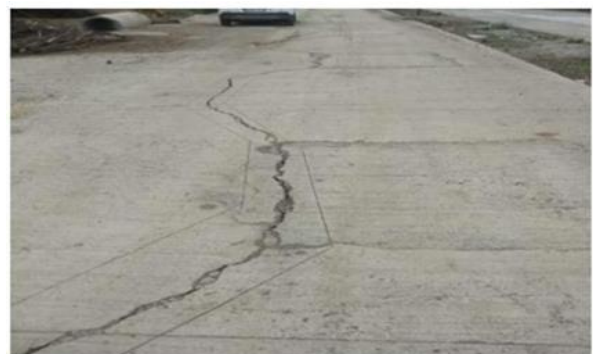
Figure No.2 Crack in the direction of traffic.

In the four cases, Case 1, Case 3, Case 4 are the cases which are responsible for the longitudinal direction cracks, parallel to direction of traffic. Case 2 is responsible for lateral direction cracks. Case 1 and Case 2 are the governing cases. The reason behind it is that the relative maximum bending moment occurs in these cases.

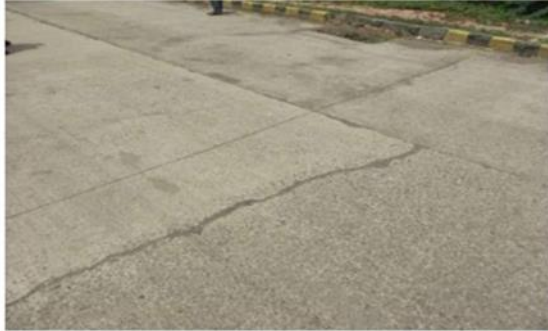
Figure No.3 Crack in direction perpendicular to traffic

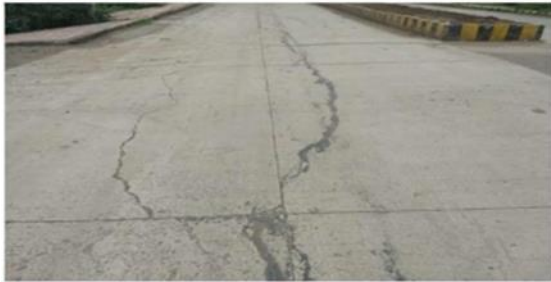
Figure No.4 Cracks on pavement repaired by filling them with bitumen
