# Accelerated Corrosion Test as a Method to Evaluate Corrosion of Rebar

**Abstract**— Corrosion of steel reinforcement leading to deterioration of concrete is caused by an electrochemical due to the formation of small anodes and cathodes, resulting in ion movement between the two electrodes. Under marine environment, the inclusion of chloride into concrete is the primary reasons of reinforcement corrosion. In the present study, 150mm x 150mm x 150mm concrete cube specimens and 8mm steel bar conforming to Bureau of Indian standard specifications was used to assess corrosion of rebar in concrete under simulated marine water immersion. A constant voltage accelerated corrosion technique was used to induce corrosion to assess the factors governing the distribution and growth of corrosion products at the steel-concrete contact that were quantitatively examined. Use of gravimetric analysis indicated that the weight of the rebar in concrete under simulated marine environment decreased by 4.4% after 62 days of exposure under accelerated corrosion testing. XRD analysis indicated highest percentage of iron oxide in corroded specimens.

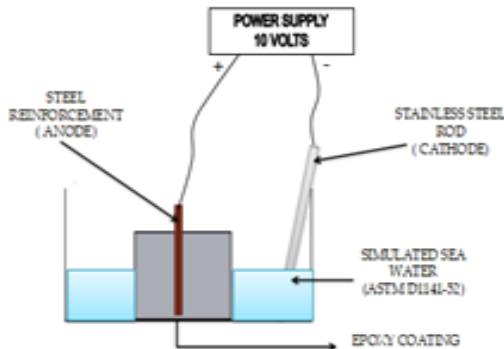
(a) Schematic presentation of the accelerated corrosion test set-up

Set-ups used for inducing reinforcement corrosion through impressed current consist of a DC power source, a counter electrode, and an electrolyte. The positive terminal of the DC power source is connected to the steel bars (anode) and the negative terminal is connected to the counter electrode (cathode). The current is impressed from counter electrode to the rebars through concrete with the help of the electrolyte (simulated marine water). The accelerated corrosion test setup schematically represented in Figure 2(a). Fig 2(b) shows the experiment under progress.

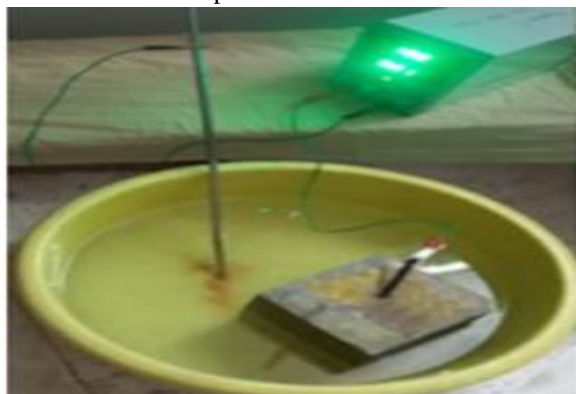
(b) Accelerated corrosion test Set-up used

The specimen was partially immersed in artificially simulated seawater prepared as per ASTM D1141-98 shown in Table.5 with salinity similar to that of natural seawater. A constant voltage of 10 volts through DC power supply was supplied to the reinforcement to account for the effect of corrosion rate on rust expansion and deposition. The bottom of the specimen was sealed with epoxy resin to prevent the Sodium Chloride (NaCl) solution from entering through the bottom surface and rust from spreading beyond the concrete and steel interface. Figure 2b depicts the accelerated corrosion test in progress.

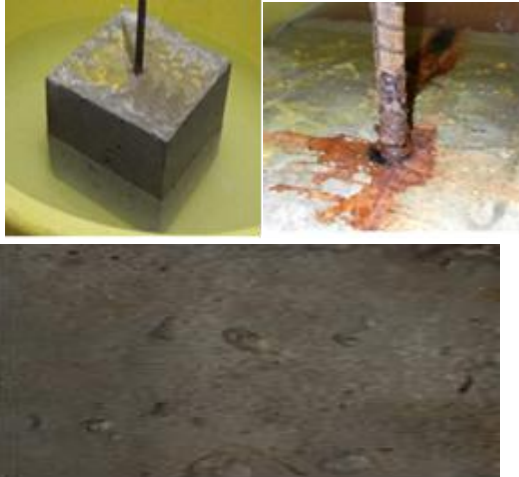
Fig.3: Stages in Deterioration of Specimen during Accelerated Corrosion Test

To evaluate the rate of corrosion at the steel-concrete interface and the effect of rust on the concrete surface, the following visual observations were made after the initiation of accelerated corrosion test, which are as shown in Fig 3. Fig.3a depicts the specimen prior to the onset of corrosion. During the first week of testing, deposition of corrosion, products were observed on the specimen's top surface at the steel-concrete interface. In addition, rust eventually began spreading/flowing vertically upwards, around the steel bar, and gathered on the top surface at the steel-concrete interface, resulting in a reduction in the steel bar's cross-section, as shown in Fig.3b.

(a) Specimen prior to corrosion (b) Rust deposition at steel concrete interface (c) Outer Concrete Surface Subjected to Spalling

Due to the diffusion of rust on the bottom surface of the concrete specimen following a 20-day immersion period, the epoxy layer at the specimen's base became weak after 20 days. Rust deposited at the steel-concrete interface exerted pressure on the surrounding concrete, resulting in an increase the concrete's porosity around the bar. It was found that the outside concrete surface was prone to spalling as shown in the Fig 3c.

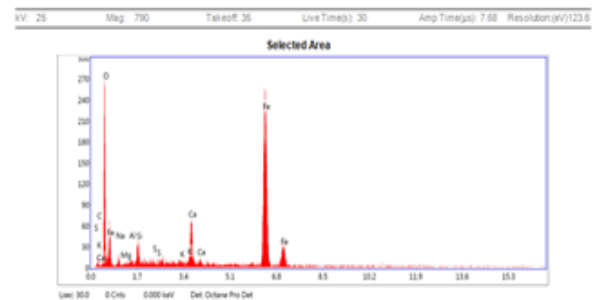
Fig.4 XRD analysis of corroded sample

X ray diffraction (XRD) analysis is carried out for phase identification of a crystalline material and to identify the compounds present in the corroded sample as shown in the Fig.4.

Figure 4 reveals the presence of a higher percentage of iron oxides, which suggests that more rust has diffused away from the steel-concrete contact. According to the results of elemental analysis, the distribution of corrosion products in deeper layers is not uniform. Before concrete cracking begins, rust only diffuses into the cement paste around the steel-concrete interface. As rust accumulates, the confinement of concrete degrades and surface fissures may spread.
