# Indian Heritage Preservation using Crack detection Model

Ved Waje<sup>1</sup>, Maanav Valecha<sup>2</sup>, Nupur Pathare<sup>3</sup>

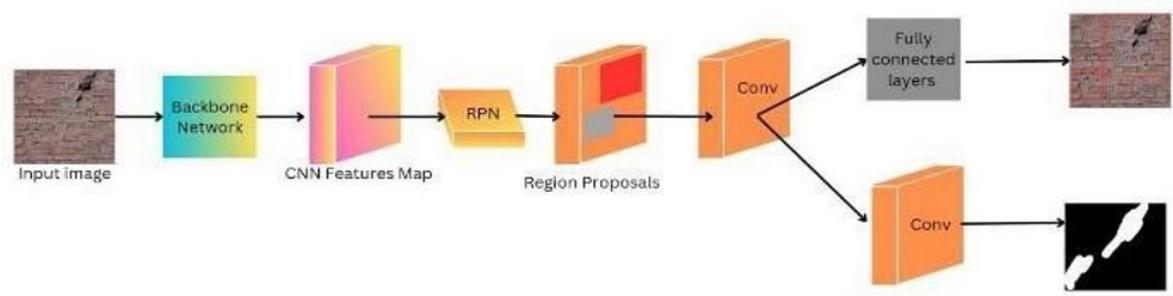
At the core of the COCO architecture is the Mask R-CNN model, an extension of the Faster R-CNN architecture, which integrates a branch for generating segmentation masks along with bounding boxes for object localization. The architecture begins with an image preprocessing stage, where adjustments such as contrast enhancement and sharpening are applied to highlight features critical for detecting cracks or structural damage. These adjustments help the model identify subtle cracks on heritage sites that might otherwise be difficult to detect.

Fig. 1. Overview of the Mask R-CNN-based crack detection architecture.

The model then employs deep convolutional layers to extract hierarchical features at multiple levels, capturing fine details such as edges, textures, and structural patterns essential for detecting cracks. A Region Proposal Network (RPN) generates candidate regions in the image where objects might be present, focusing specifically on areas where cracks or other structural damages are likely to occur. Once these regions are identified, RoI Align is used to precisely extract features, ensuring accurate segmentation of the detected cracks. The Mask R-CNN then generates a segmentation mask for each region, outlining the exact shape and boundaries of the crack (Figure 1). Finally, the system assigns a confidence score to each detection, indicating the model's certainty in the accuracy of its predictions. This approach, when applied to the detection of cracks on Indian heritage sites, proves invaluable for automating the monitoring and preservation process, enabling early identification of damage while minimizing the potential for human error during manual inspections. The system is specifically designed to streamline the process of identifying and categorizing various types of cracks in images of historical monuments through an accessible and user-friendly web-based platform. By facilitating efficient and accurate detection of

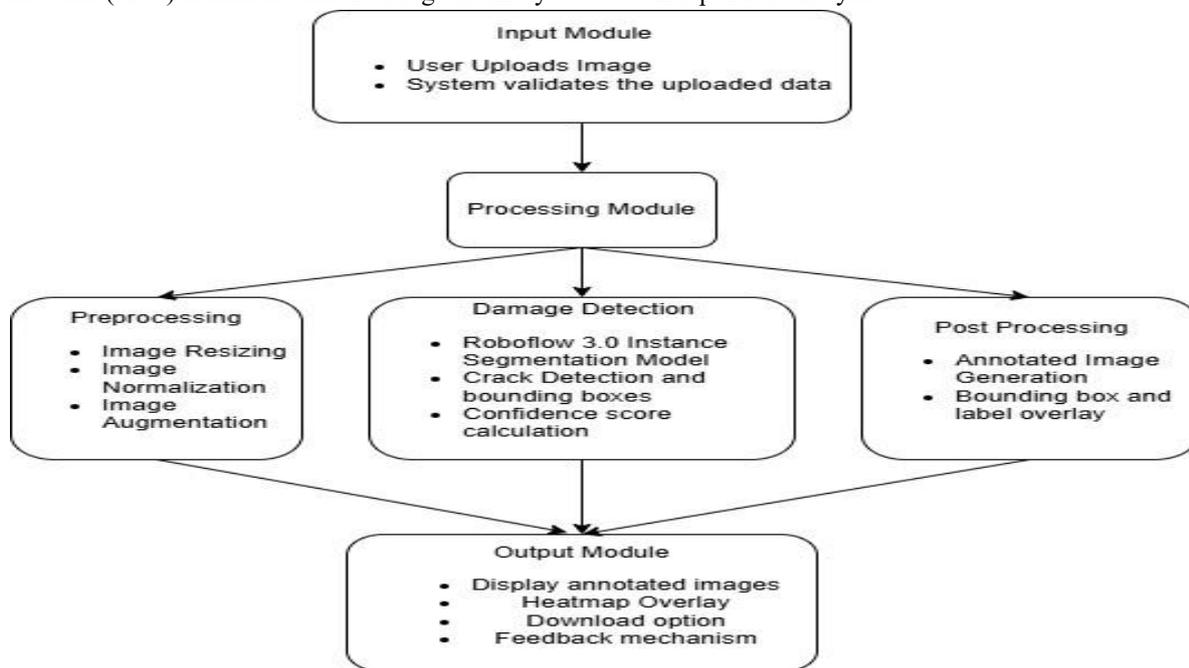
As shown in Figure 2, the architecture of the proposed system is divided into three primary modules: Input, Processing, and Output.

1) *Input Module:* The input module provides a web-based platform developed using Streamlit, designed to offer a userfriendly interface for users to upload images through a drag-and-drop feature or file selection component. The platform includes detailed instructions on acceptable file formats and recommended image quality. In addition, example images are provided to guide users in selecting suitable input images for analysis. These measures

2) *Processing Module:* The processing module consists of three key stages: preprocessing, damage detection, and postprocessing.

3) *Output Module:* The output module is responsible for presenting the results to the user in a structured and interpretable manner. The annotated images highlighting the detected damages are displayed within the web-based interface. Users can interact with the images through zoom and pan functionalities, allowing for a detailed examination of the detected structural defects. Additionally, an option is provided to download the annotated images, enabling users to retain records or conduct further independent analysis.

4) Fig. 2. General Framework Architecture

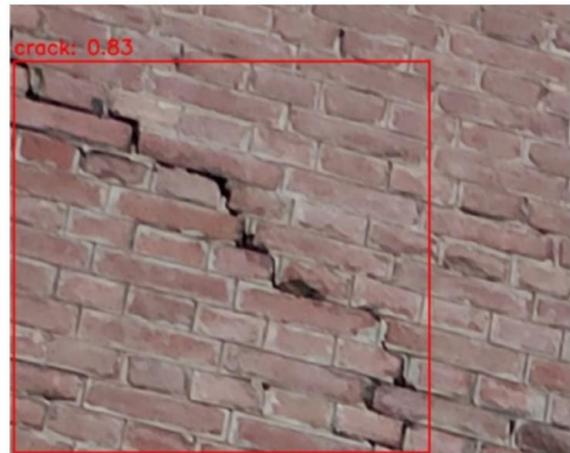
Once preprocessing is complete, the crack detection algorithm processes the images, generating bounding boxes

Fig. 7. Crack detection with bounding boxes.

that highlight detected cracks along with confidence scores

(Figure 7).

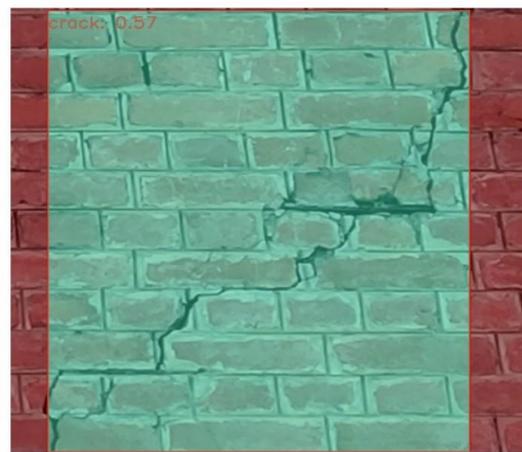
A heatmap overlay is also generated, visually representing the concentration and confidence levels of detected cracks within the image. The processed images, including detected cracks and heatmaps, can be downloaded for further analysis or documentation (Figure 8).

Fig. 8. Heatmap Overlay.

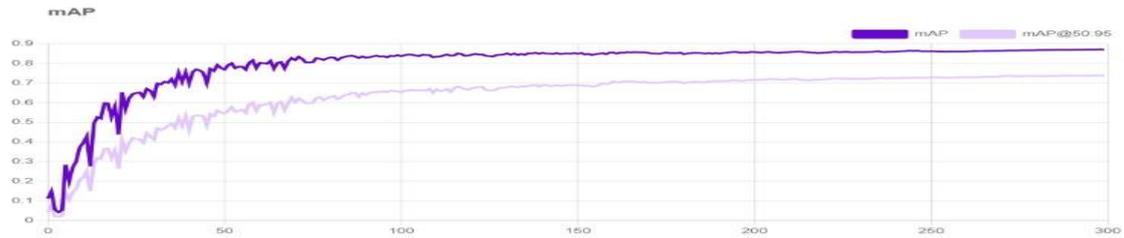
Fig. 12. Mean Average Precision graph.

The mAP progression further validates the model's performance, with Figure 12 demonstrating both mAP@0.5 and mAP@50:95 trends. The mAP@0.5 metric rapidly increases to approximately 85% within the first 100 epochs and stabilizes at 87.8% by the final epoch, indicating high detection accuracy. Additionally, the mAP@50:95 metric follows a steady upward trajectory, reaching approximately 79%, underscoring the model's robustness in detecting cracks across varying intersection over union (IoU) thresholds. These results collectively affirm the model's strong generalization capability and effectiveness in real-world crack detection scenarios.

Figures 12 and 13 illustrate the model's training progress over 300 epochs, highlighting the convergence of Box Loss, Class Loss, and Object Loss (Figure 13), as well as the progression of Mean Average Precision (mAP) (Figure 12). The loss metrics exhibit a sharp decline within the initial 50 epochs, indicating rapid feature learning, followed by stabilization around epoch 100. By epoch 300, the final loss values remain consistently low, with Box Loss, Class Loss, and Object Loss converging to approximately 0.6, 0.8, and 0.8, respectively. This trend suggests effective feature extraction while minimizing overfitting.

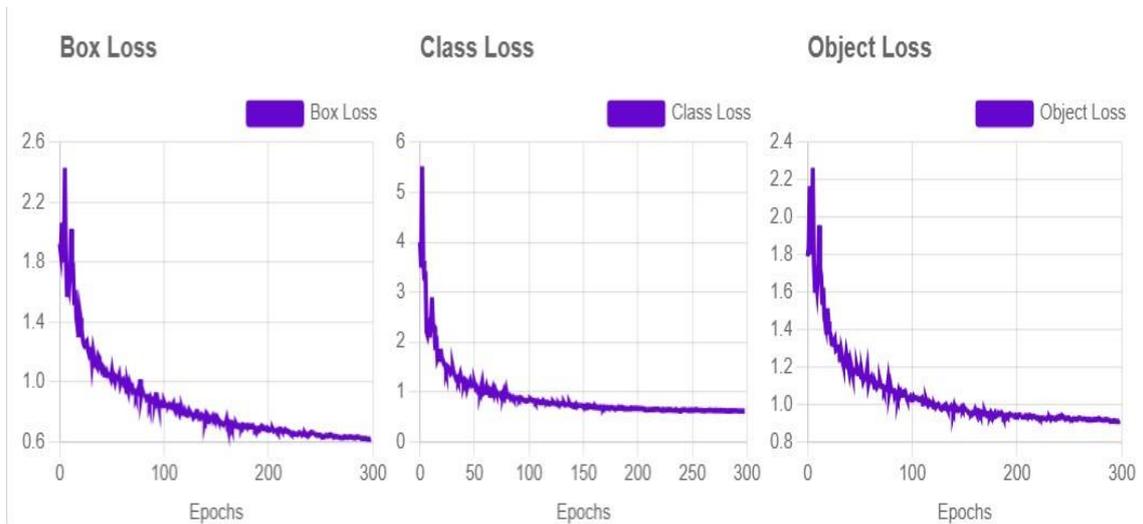
Fig. 13. Box loss, Class loss and Object loss.
