Evaluation of Walkability Using GIS: A Case Study of Pune Metro Stations

Abstract—Despite substantial investments in upgrading metro infrastructure, the overall effectiveness of a public transit system can be significantly undermined if pedestrian access to metro stations is overlooked. Integrating pedestrian access into transit planning is essential to fully realize the benefits of metro investments and to boost ridership and system performance. Hence, the present study assesses the existing conditions of pedestrian walkways using GIS for spatial analysis. A case study was done at three metro station in Pune those were PCMC metro station, Ramwadi metro station and Nal Stop metro station. With PCMC metro station being named the metro station with highest footfall by Maha Metro Rail Corporation. The study focuses on a 500-meter radius around three metro stations PCMC, Nal Stop and Ramwadi with a practical walking distance from key transit points. The data was collected by field survey. Utilizing Geographic Information Systems (GIS) for spatial analysis, the approach assessed critical walkability factors, including safety, connectivity, comfort, and infrastructure quality. The study

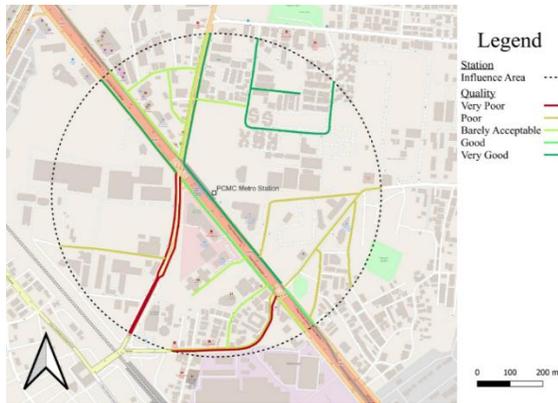
Figure 1. PCMC Metro Station Walkability

- Dark red = very poor (value between 4-5)

- Dark green = very good (value between 0-1)
- Neon green = good (value between 1-2)
- Light green = barely acceptable (value between 2-3)
- Yellow = poor (value between 3-4)

Based on the Data and GIS analysis, it was observed that pedestrian footpaths near the PCMC metro station are predominantly in substandard condition. Specifically, 12.5% of the footpaths are in a very poor state, while 25% are classified as poor. Additionally, about 33.33% of the footpaths are in barely acceptable condition, indicating limited usability and comfort for pedestrians. Only 8.33% of the footpaths are in good condition and considered favorable for walking. Meanwhile, 20.83% of the footpaths are in very good condition but still require routine maintenance to sustain their quality.

All in all, Ramwadi Metro Station stands out with the highest proportion of good-quality footpaths 35.71%, suggesting better overall pedestrian infrastructure. PCMC Metro Station has the largest share of poor and barely acceptable footpaths 70.83%, indicating a pressing need for upgrades. Nal Stop Metro Station presents a more balanced condition, with a relatively low percentage of footpaths in poor or very poor condition 15% and a notable 25% in very good condition. Across all stations, barely acceptable footpaths make up a significant portion, especially at Nal Stop 40% and PCMC 33.33%, pointing to general maintenance and quality challenges.

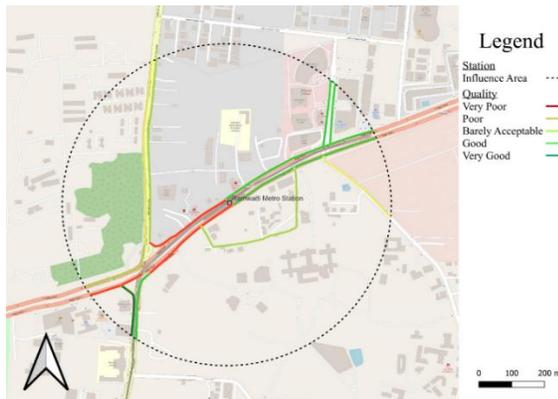
Figure 2. Ramwadi Metro Station Walkability

Based on the data and GIS analysis, it was found that near Ramwadi metro station, 21.42% and 14.28% of the pedestrian footpaths are in very poor and poor condition, respectively. Additionally, around 21.42% of the footpaths are in barely acceptable condition. Approximately 35.71% of the footpaths are in good condition and suitable for walking, while 7.17% are in very good condition and require regular maintenance

to preserve their quality. This data highlights that a significant portion of the footpath infrastructure requires improvement, with only about 43% currently in good or very good condition.

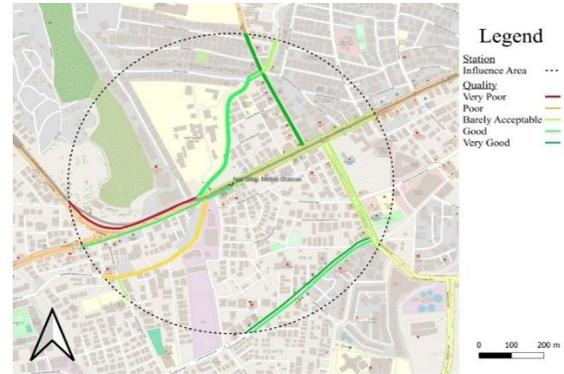
Figure 3. Nal Stop Metro Station Walkability

From the data and GIS analysis it is observed that only 5%, 10% of pedestrian footpath near Nal stop metro station is in very poor and poor condition respectively. Whereas around 40% of footpath is in barely acceptable condition. It is obtained that 20% of footpath is in good condition and favourable to walk. About 25% of footpath is in very good state and needs to be maintained.

A significant portion of the footpaths 40% are in barely acceptable condition, indicating room for improvement in pedestrian infrastructure. Only 15% of the footpaths fall under poor or very poor condition, which is relatively low compared to other metro station areas. With 45% of the footpaths in good or very good condition, the overall pedestrian environment near Nal Stop shows promise, but targeted upgrades are still necessary.
