A Study of Submerged Heritage from the Salaulim Dam of South Goa

Laxmi Yogi¹, P. D. Sabale²

^{1,2}*Deccan College Post Graduate and Research Institute, Deemed University, Pune-411 006*

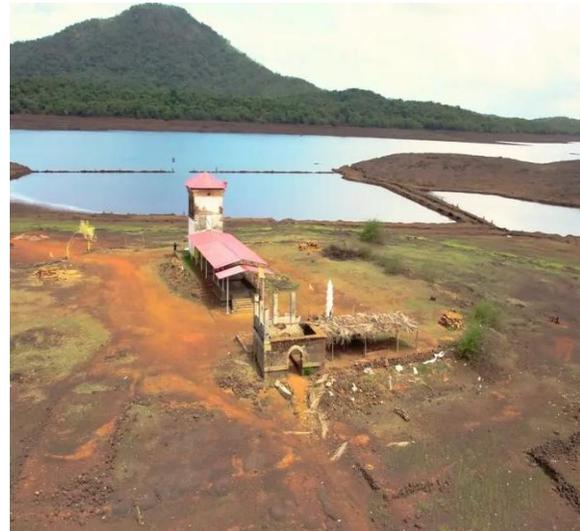
Following the construction of the Salaulim Dam in the 1970s–80s, the village was fully submerged, and its accessibility became seasonal; June–February site remains underwater, while March–May, reservoir levels drop, revealing roads, foundations, and the Someshwar temple (Times of India, 2022) (Fig. 2). This seasonal exposure makes Curdi an important but time-sensitive archaeological landscape.

Fig. 2, Aerial view of Curdi’s landscape showing seasonally uncovered heritage features.

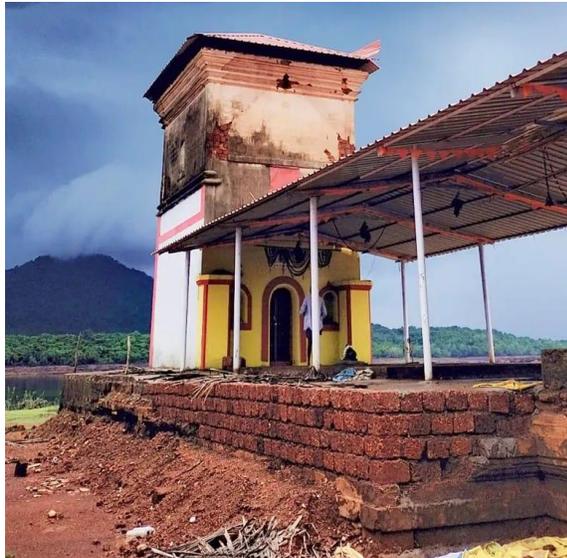
Weathering is also a very important factor which is responsible for deteriorating the Heritage and which causes the maintenance of heritage. Therefore, the maintenance is directly proportional to the rate of weathering. In the present context the temple is affected by the effect of three types of weathering's; namely physical, chemical, and biological during the field investigation each and every corner of the temple complex were observed and the type of weathering which is responsible to damage the particular part of the heritage were noted in the field notebook (Fig. 3).

On the basis of weathering, it is concluded that the submerged part of the temple which is routinely coming in contact with dam water was badly affected by the chemical weathering process. Mostly this type of weathering is found on the temple base and the lower laterite stones, where repeated immersion has caused softening, flaking, and loss of material.

Fig. 3, Chemical and physical weathering on the temple heritage caused by prolonged water contact.

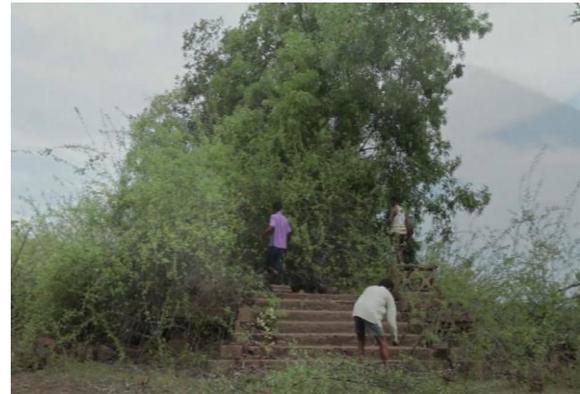
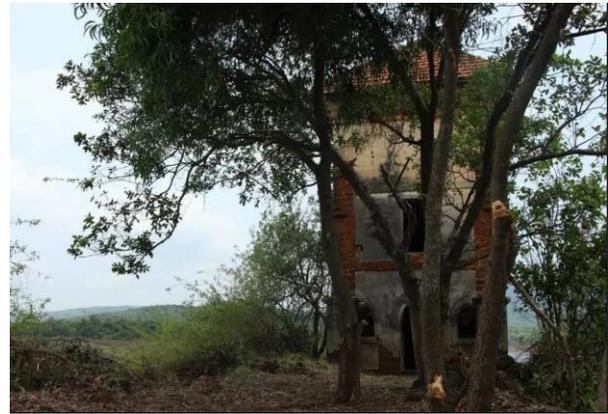
As far as the physical weathering is concerned, the development of the microcracks, cracks, joints and fractures were observed on the temple is most evident

on the lower laterite stones and the exposed base of the structure. The front portion of the temple base shows clear signs of material loss, where the laterite blocks have become uneven, broken, and eroded due to repeated wetting and drying cycles. Small cracks, missing edges, and dislodged stones indicate the impact of hydraulic pressure from the reservoir water. The soil around the base also appears loosened and washed away, suggesting surface erosion and abrasion caused by flowing water and sediment movement (D'Souza, 2018) (Fig. 4).

Fig. 4, Vegetation growth (biological weathering) on the heritage (a) Bushes at the entry, (b) big trees in front of temple (Gurucharan K., 2015).

While due to the effect of vegetation growth on the temple the whole upper portion of the temple was damaged due to the growth of big trees, these trees were removed in 2015, since then heritage is free from big trees.
