# Detection And Analysis of Structural Leakage Using Thermal Imaging Techniques

Pathan Shadabkhan Yavarkhan

*PG Student Structure Engineering Silver Oak University Ahmedabad, Gujarat, India*

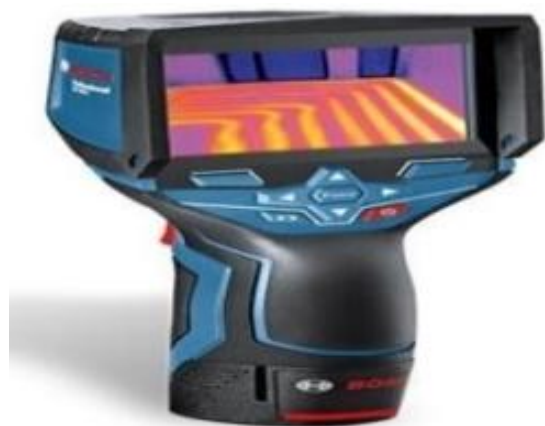
Figure 1 Thermal Camera Image

Figure 1. Shows BOSCH Company Thermal camera image which I use in my thesis.

A thermal camera consists of:

Infrared detector, Lens, Display screen

Image processing system The camera captures infrared radiation and displays it as a color image.

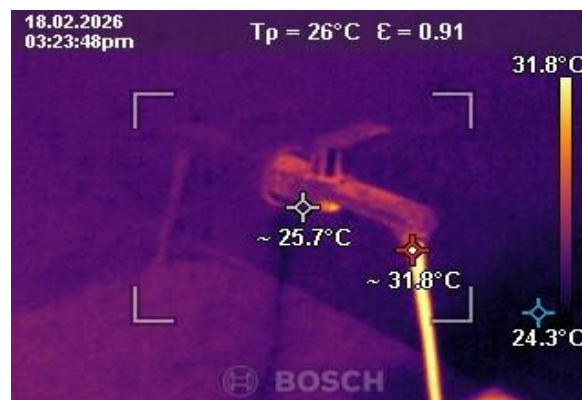
Figure 3 Shows Water Tap Leakage
