# Study Of Basic Amenities in Tourist Places

Aditi A. Gulwade<sup>1</sup>, Ar. Shekharsingh Thakur<sup>2</sup>

<sup>1</sup>Student, Sipna School Of Planning and Architecture, Amravati, India

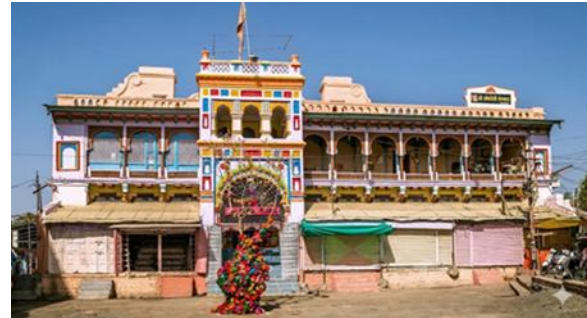
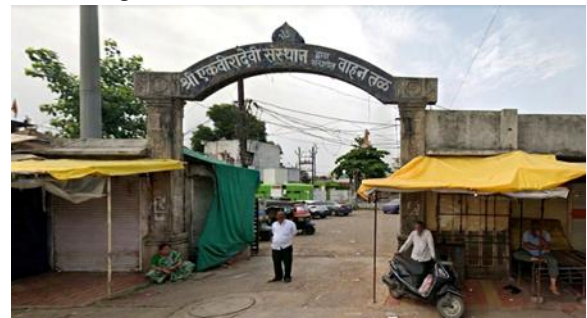
## A. Shri Amba Devi Sansthan, Amravati.

- Sanitary facilities are available within the temple complex but not in the car parking areas. Facilities to cater to the needs of people with disabilities are missing.

- A handpump is located in the car parking area but does not comply with the prescribed standards for water. Poor maintenance of facilities affects their functioning and hygiene.
- A dedicated parking area is provided by the temple trust, which is about 250 meters from the temple premises and is primarily utilized by buses and other large vehicles. However, two-wheelers park near the temple gate and cause informal roadside parking congestion between pedestrians and vehicular traffic.
- Proper planning for parking and security is not available. Seating facilities are not provided permanently in the parking areas.

- Though signage is available at entrances and within the premises, navigation is done with respect to the flow of the crowd.
- Way finding facilities are missing, with no visual hierarchy and multilingual signs.
- Provisions for accessibility like ramps are available only at select entrances.

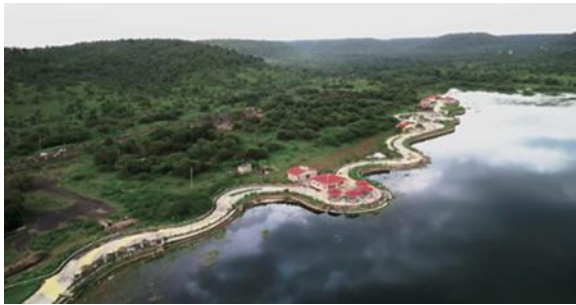
#### B. Chatri Talao, Amravati.

- Toilets are available at the lakeside garden and entry points, but cleanliness is quite basic and needs to be improved. Water supply services are poor and insufficiently distributed throughout the site.
- Parking space is available at the entry points and along the adjacent roads, but there is no organized and structured planning.
- Shade benches are available at the lakeside for convenience purposes.
- Signage is visible at the entry point and throughout the garden, but it is poor because of its poor visibility and lack of clarity.

- Wayfinding is poorly planned, with inadequate guidance, lack of zoning information, and poorly coordinated signage hierarchy.
- The site is easily accessible, allowing wheelchairs to access.

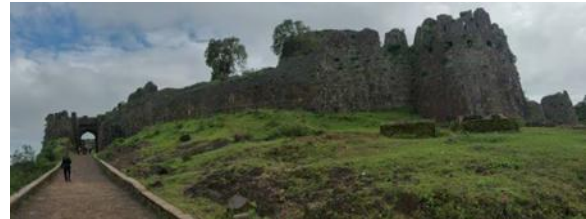
#### C. Gavilgarh Fort, Chikhaldara, Amravati.

- Absence of proper facilities of sanitation or drinking water inside the premises of the fort.
- Visitors have to depend on the basic facilities available outside in Chikhaldara town or carry water with themselves.
- The lack of proper facilities creates difficulties for the visitors, especially the trackers who stay longer.
- There is no formal provision for parking space near the entrance of the fort.
- The present parking facilities are adequate only for fewer numbers of visitors and cannot cater to a large number of tourists.
- Visitors make use of natural elements like stones and platforms for resting; however, there is no proper seating facility available even though there is enough space.

- Inadequate signs at the entrance of the fort; hence, the visitor finds it difficult to navigate inside the fort. No proper informational or interpretation tools provided to assist the visitors.
- It is difficult to access inside the fort for disabled peoples due to natural terrain acting as a significant constraint for movement.
