# Structural Audit on Badlapur Skywalk

The structure under inspection, the Badlapur (East-West) Skywalk, is a composite structure constructed by the Mumbai Metropolitan Region Development Authority (MMRDA) circa 2009-2011, located in Badlapur. The skywalk is currently under BADLAPUR MUNICIPAL COUNCIL (KBMC)'s management.

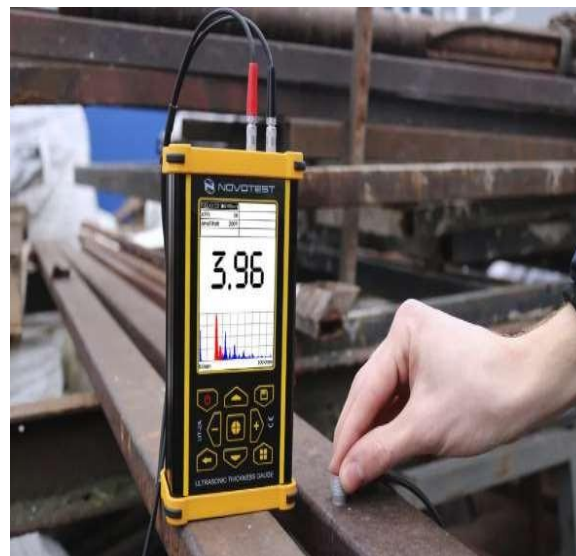
An ultrasonic thickness gauge measures the reduced thickness of corroded steel components by utilizing the properties of sound waves to detect changes in material thickness.

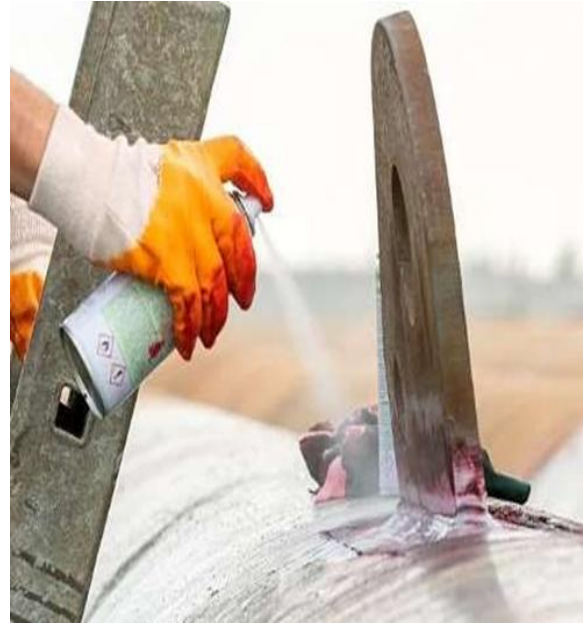
The dye penetration test (DPT) is a useful method for detecting cracks in steel components, particularly in welded joints, due to its ability to reveal surface-breaking defects. Here's how the test specifically identifies cracks in these contexts:

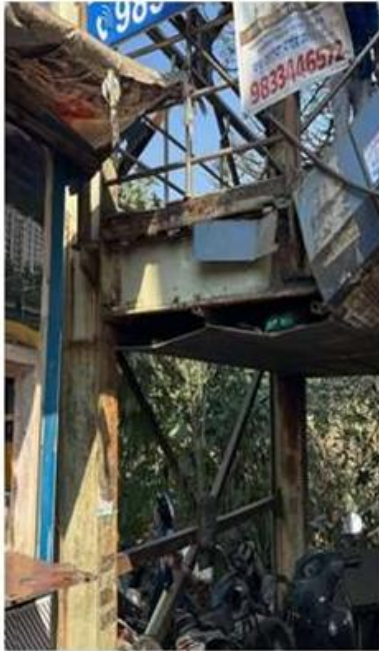
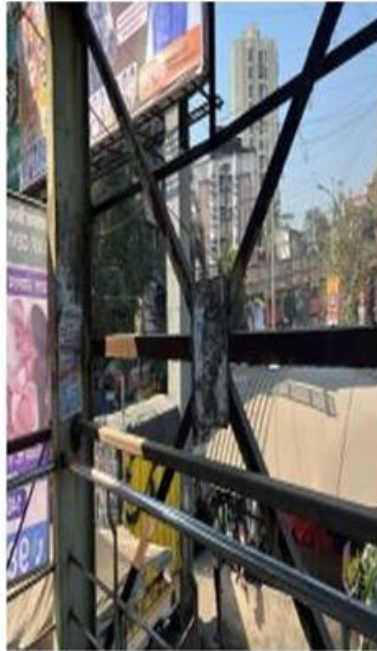
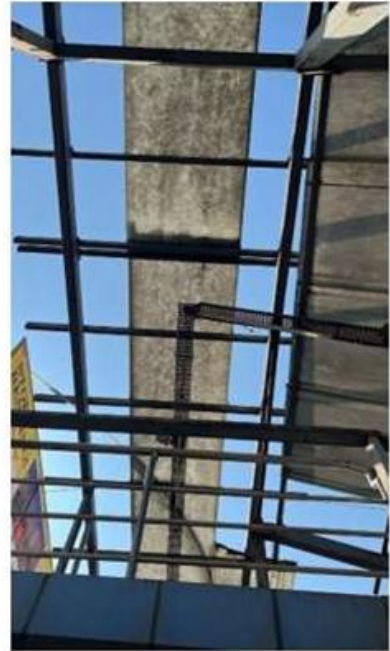
1. Staircase columns corroded. ACP cladding damage.
2. Bracings highly corroded.
3. Staircase roof sheet damage.

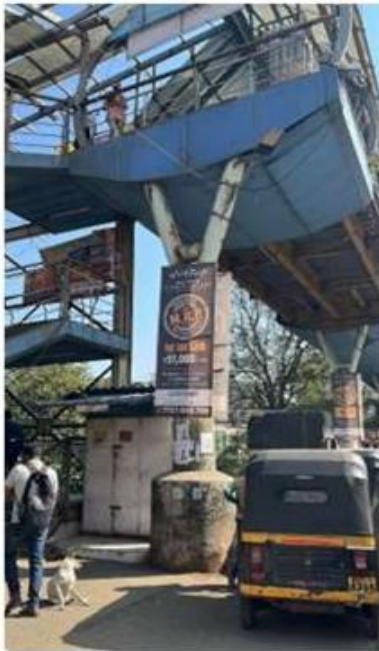
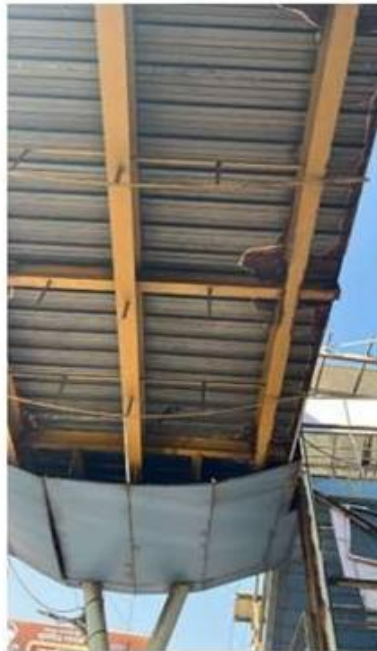
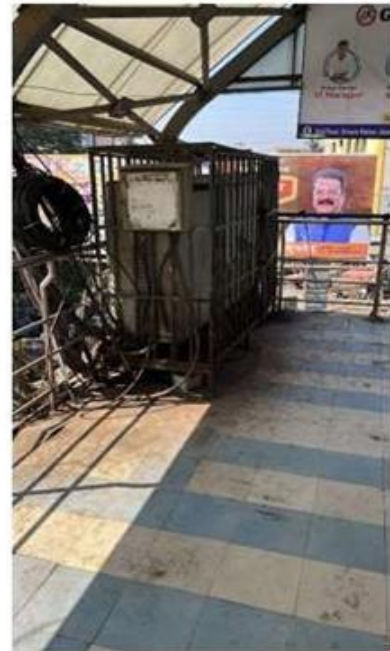
PIER 1 TO PIER 2: -

(VIEW OF PIER, DECK SLAB, FLOOR AND ROOF)

1. Pier 1- Surface corrosion detected on exposed steel members.
2. ACP Cladding damaged of deck slab, girder beam corroded.

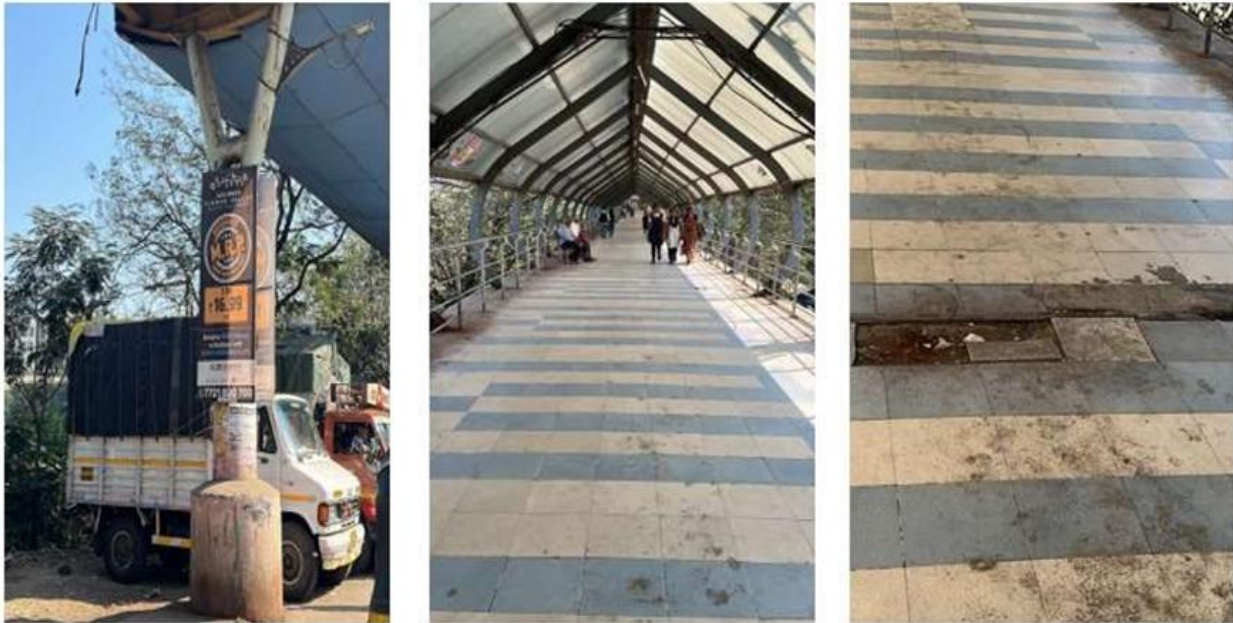
PIER 2 TO PIER 3: -

(VIEW OF PIER, DECK SLAB, FLOOR AND ROOF)

1. Pier 2- Surface corrosion detected on exposed steel members.
2. Flooring tiles damaged near expansion joint. Cleaning required.

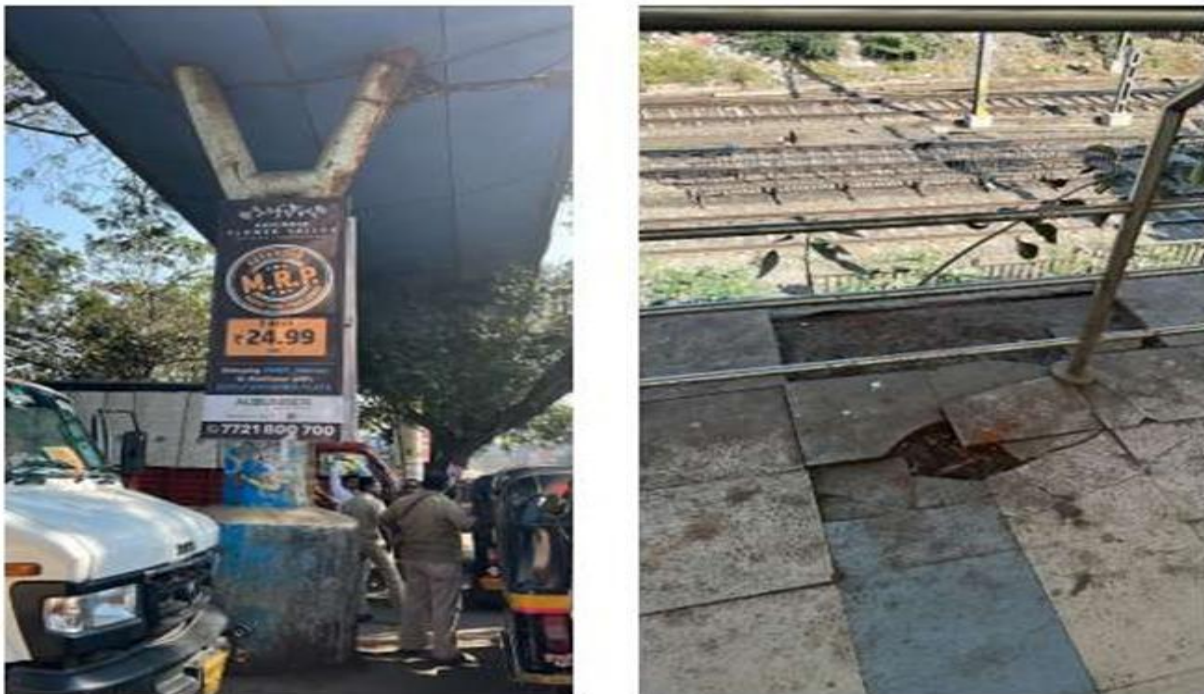
PIER 3 TO PIER 4: -

(VIEW OF PIER, DECK SLAB, FLOOR)

1. Pier 3- Surface corrosion detected on exposed steel members.
2. Flooring tiles damaged near expansion joint.

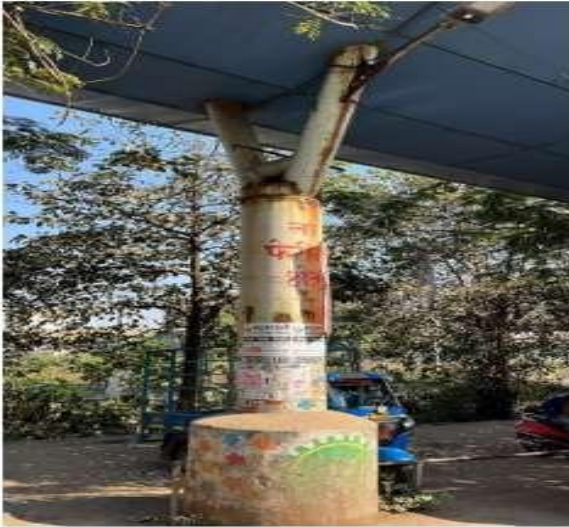
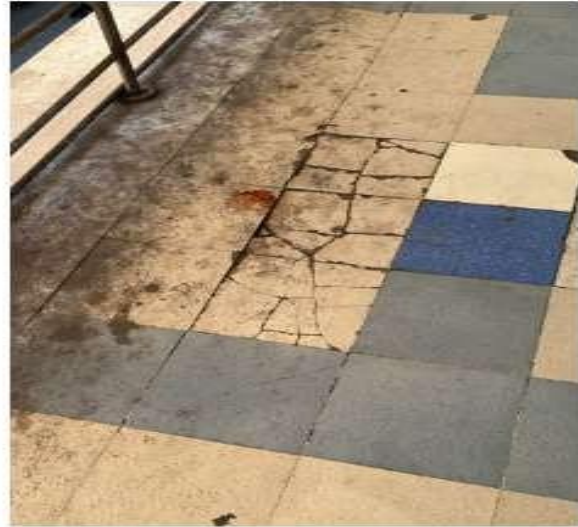
PIER 4 TO PIER 5: -

(VIEW OF PIER, FLOOR)

1. Pier 4- Surface corrosion detected on exposed steel members.
2. Flooring tiles damaged.
3. Cleaning required.

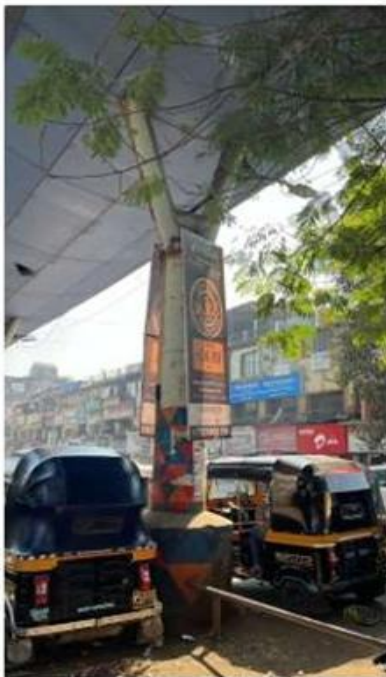
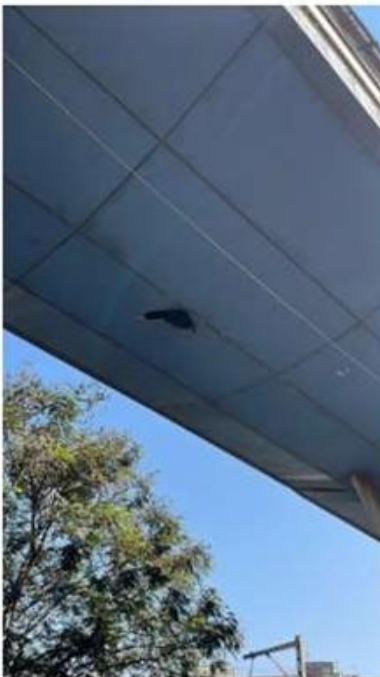
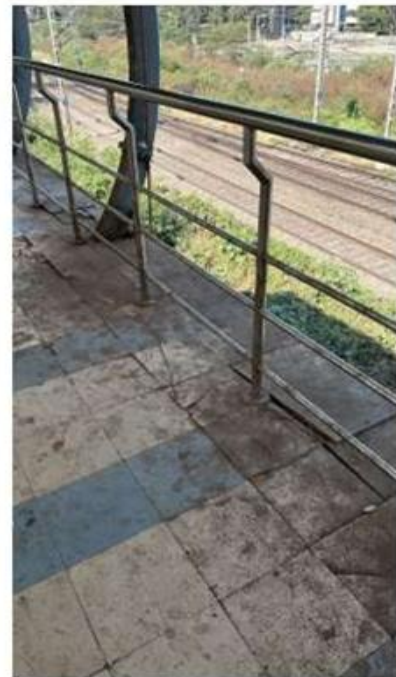
PIER 5 TO PIER 6: -

(VIEW OF PIER, DECK SLAB, FLOOR)

1. Pier 5- Surface corrosion detected on exposed steel members.
2. Deck slab (ACP cladding) damaged.
3. Flooring tiles damaged.

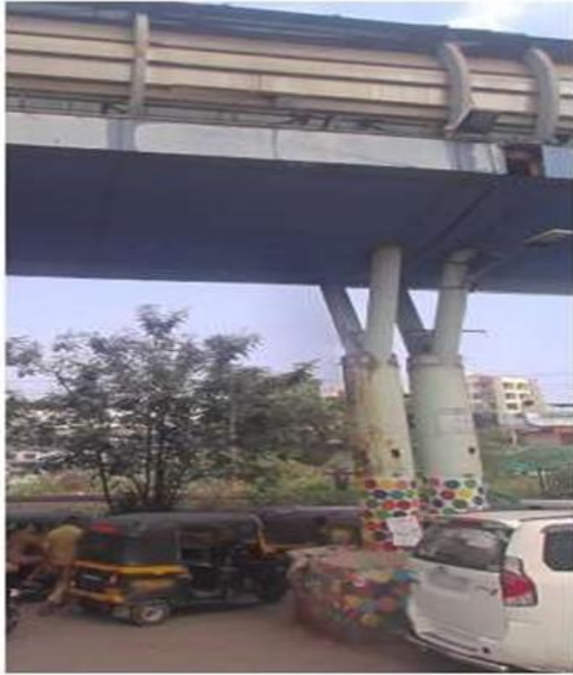
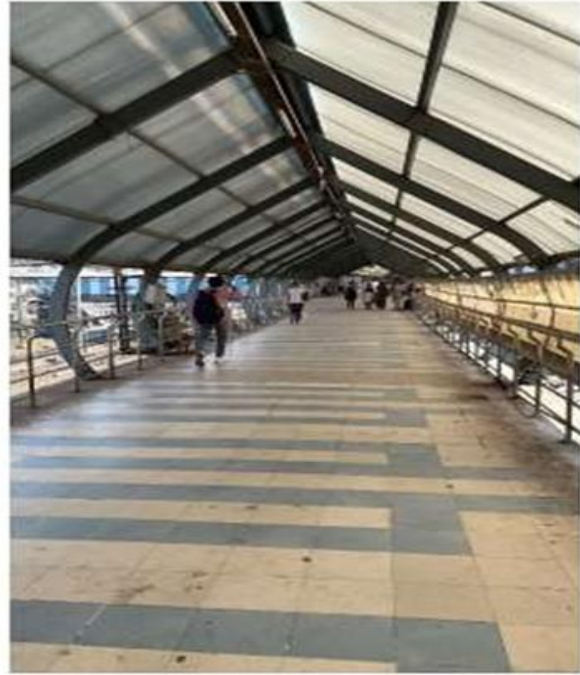
PIER 6 TO PIER 7: -

(VIEW OF PIER, DECK SLAB, FLOOR AND ROOF)

1. Pier 6&7- Surface corrosion detected on exposed members.

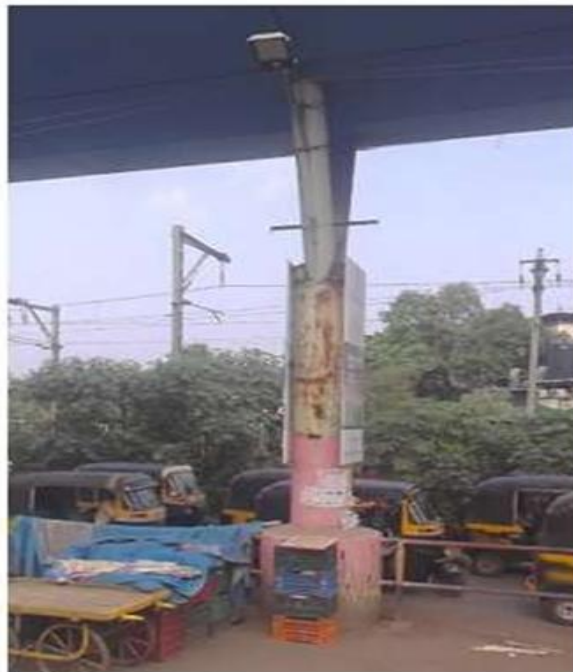
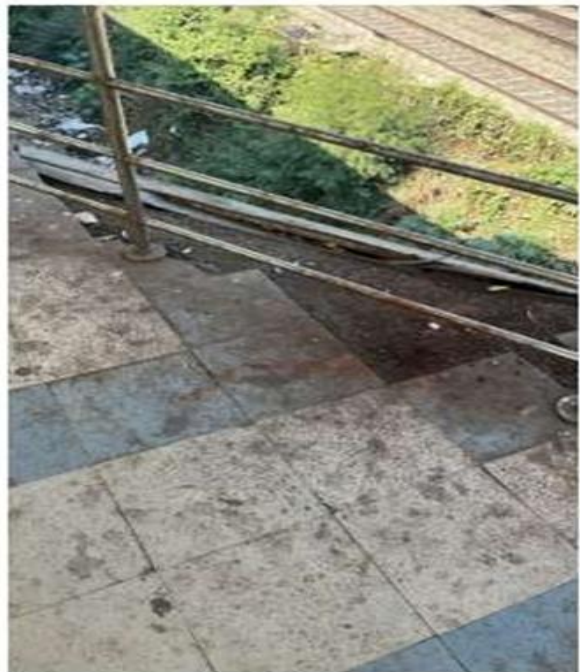
PIER 8 TO PIER 9: -

(VIEW OF PIER, DECK SLAB, FLOOR)

1. Pier 9- Major surface corrosion detected on exposed steel members.
2. Flooring damaged.

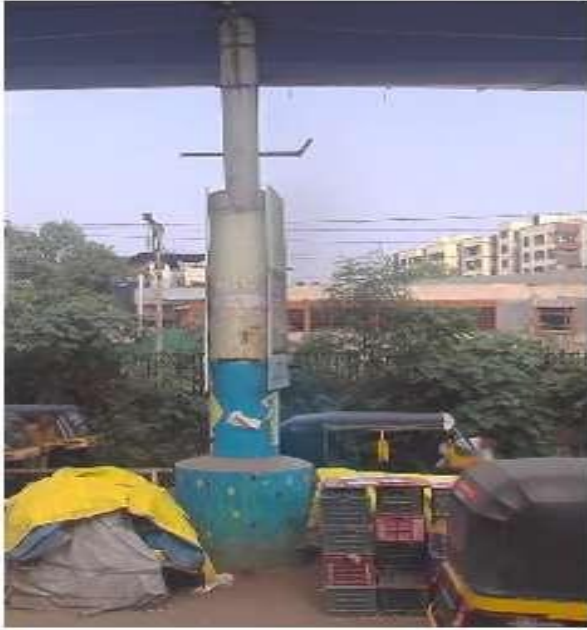
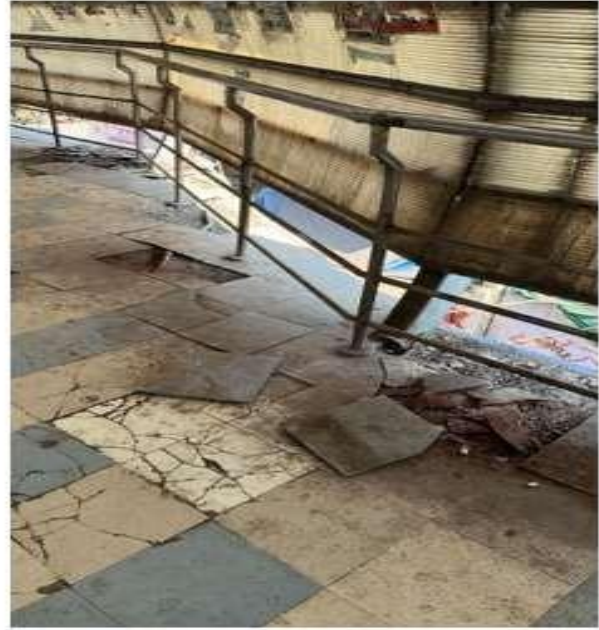
#### PIER 9 TO PIER 10

(VIEW OF PIER, DECK SLAB, FLOOR)

1. Pier 10- Surface corrosion detected on exposed steel members due to inadequate maintenance.
2. Flooring damaged.

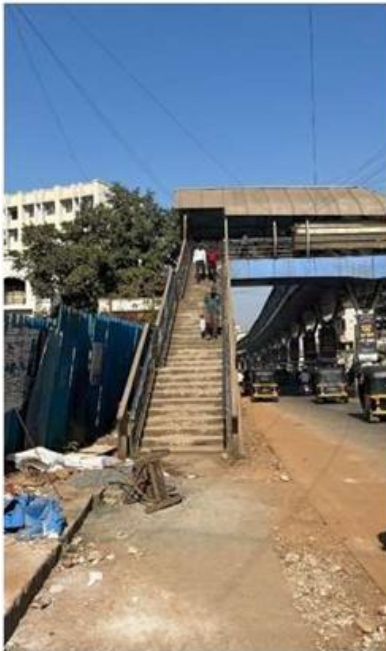
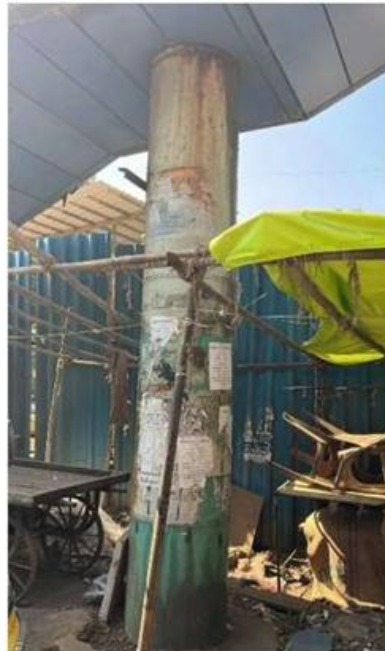
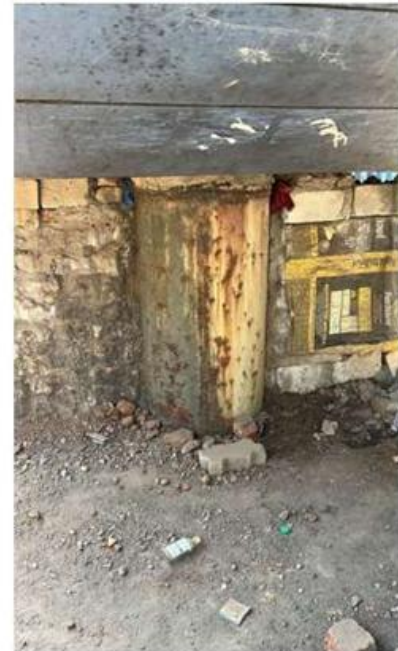
#### STAIRCASE 4

(VIEW OF STAIRCASE)

1. Surface corrosion detected on exposed steel members.
2. Uneven tread and raiser.

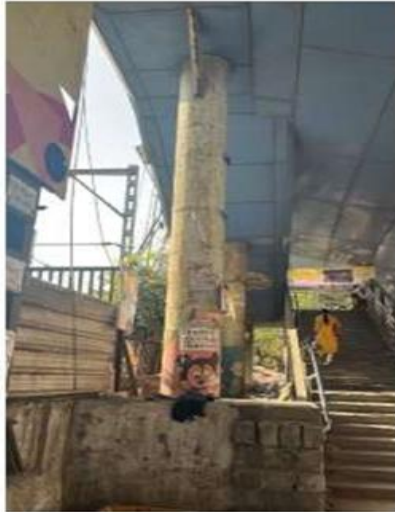
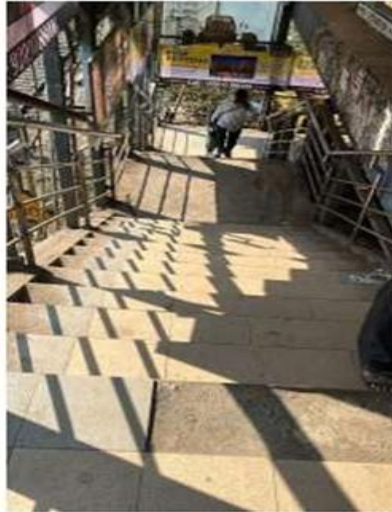
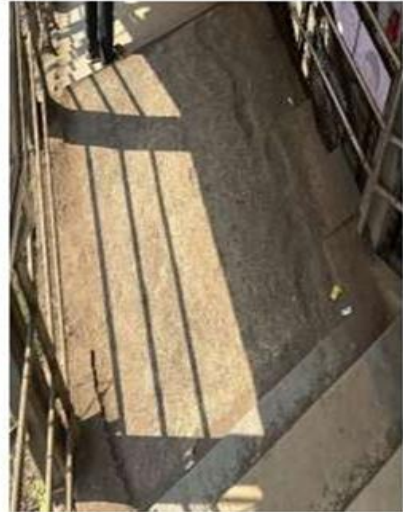
WEST SIDE SKYWALK  
STAIRCASE 1:

(VIEW OF STAIRCASE)

1. Surface corrosion detected on exposed steel members.
2. Uneven tread and raiser.
3. Flooring tiles damaged.

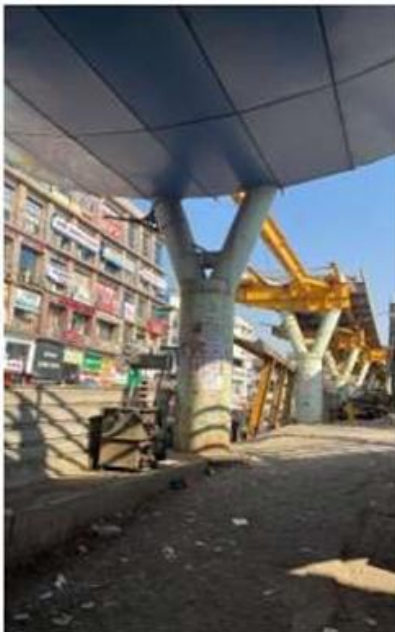
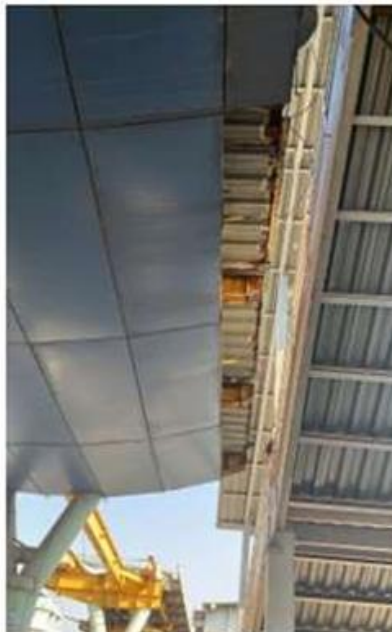
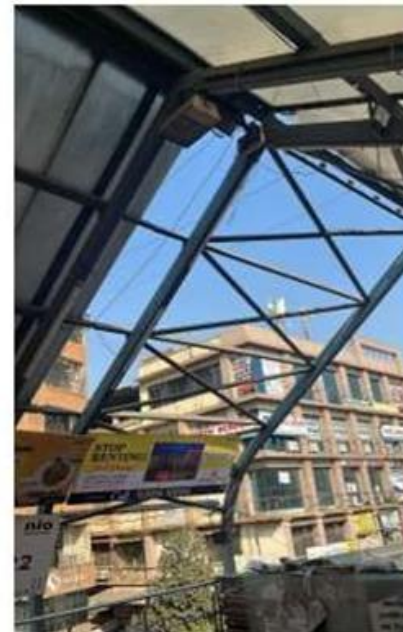
PIER 1 TO PIER 2: -

(VIEW OF PIER, DECK SLAB, ROOF)

1. Pier 1- Surface corrosion detected on exposed steel members.
2. ACP Cladding damaged.
3. Roof sheet damaged.

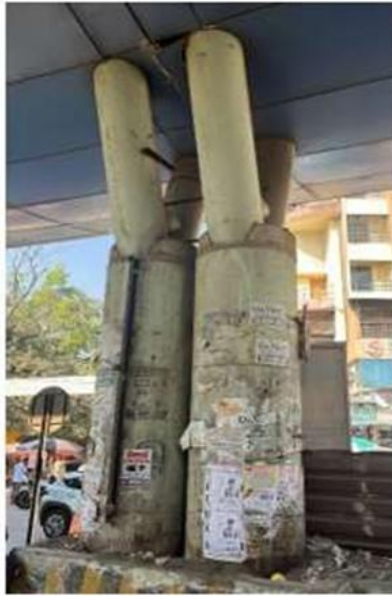
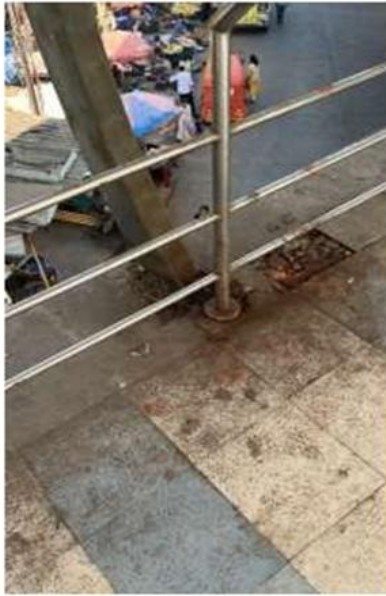
PIER 2 TO PIER 3: -

(VIEW OF PIER, FLOOR, ROOF)

1. Pier 2&3- cleaning required.
2. Flooring damaged. Cleaning required.
3. Roof damaged majorly.

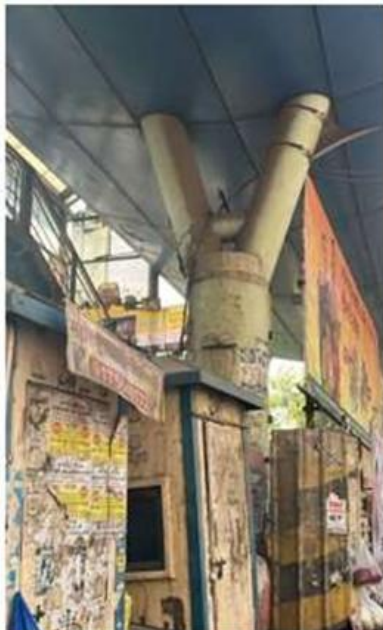
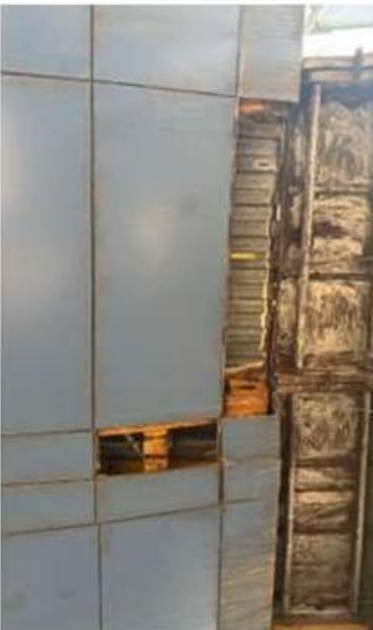
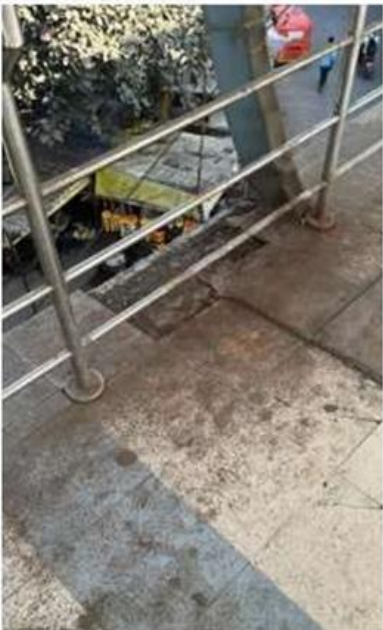
PIER 3 TO PIER 4: -

(VIEW OF PIER, DECK SLAB, FLOOR)

1. Pier 4- cleaning required.
2. Deck slab (ACP Cladding) damaged.
3. Flooring damaged. cleaning required.

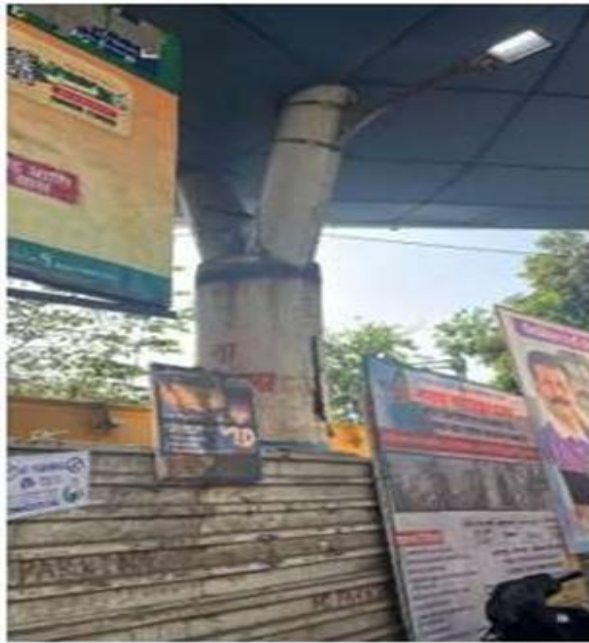
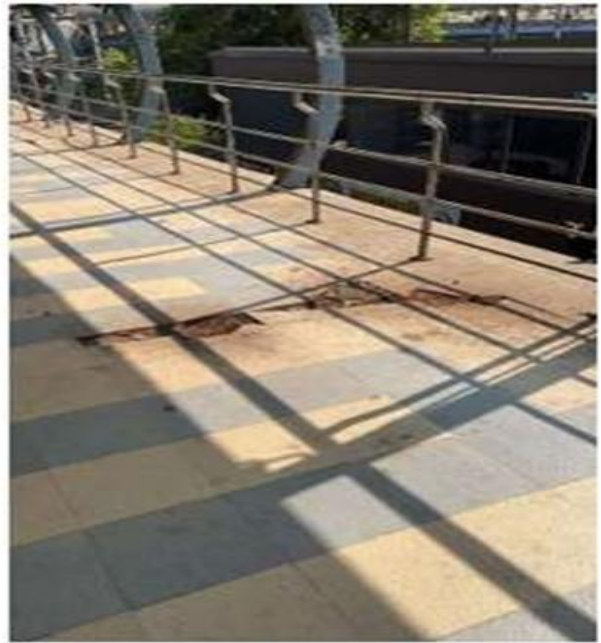
PIER 4 TO PIER 5: -

VIEW OF PIER, DECK SLAB, FLOOR)

1. Pier 5- Surface corrosion detected, cleaning required.
2. Flooring damaged. cleaning required.

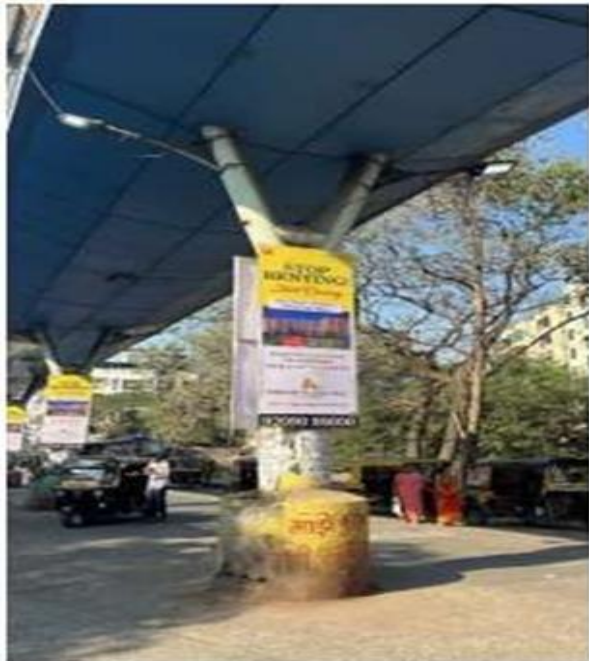
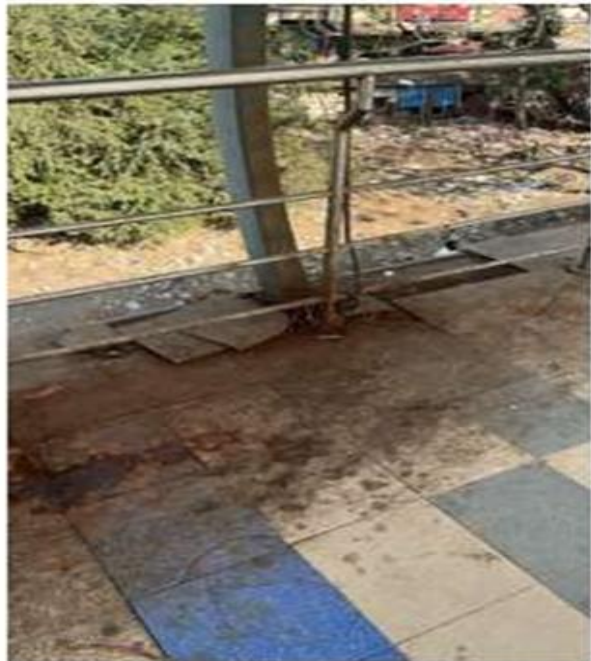
PIER 5 TO PIER 6: -

(VIEW OF PIER, DECK SLAB, FLOOR)

1. Pier 6- cleaning required.
2. Flooring damaged.

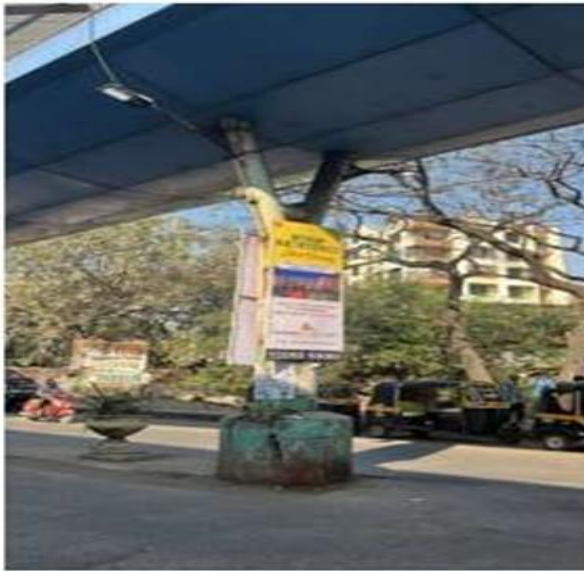
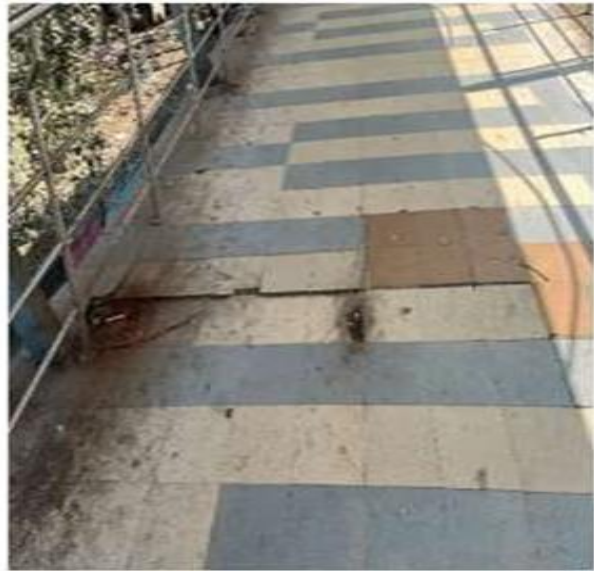
PIER 6 TO PIER 7: -

(VIEW OF PIER, DECK SLAB, FLOOR)

1. Pier 7- Surface corrosion detected, cleaning required
2. Flooring damaged. cleaning required.

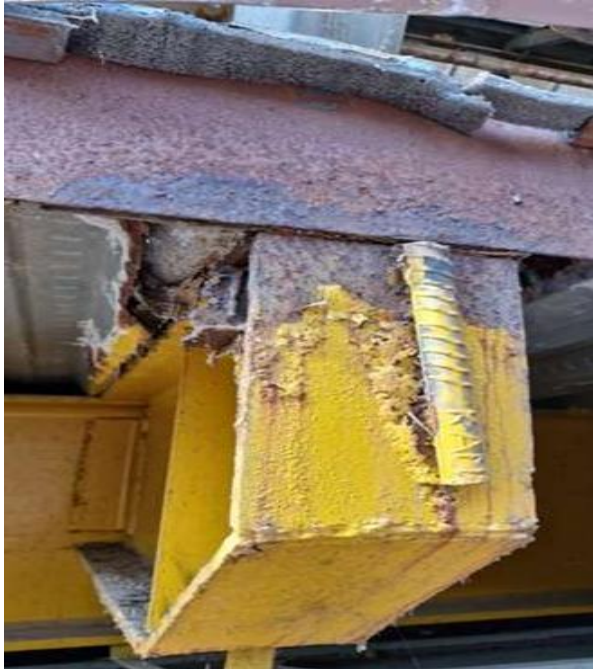
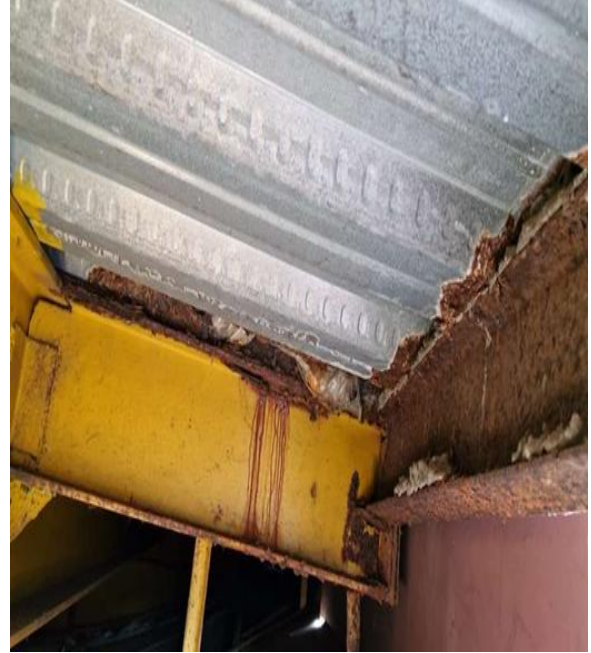
(VIEW OF PIER, DECK SLAB)

1. Pier 19- Surface corrosion detected on exposed steel members.
2. Observed runner beam and deck sheet corroded.

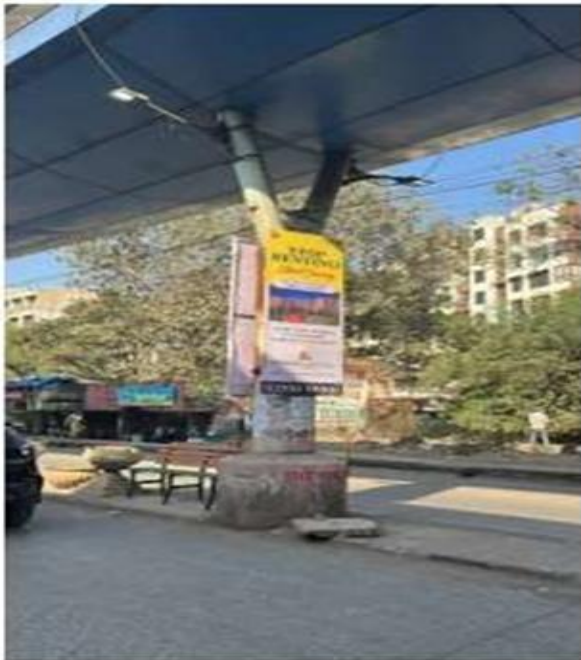
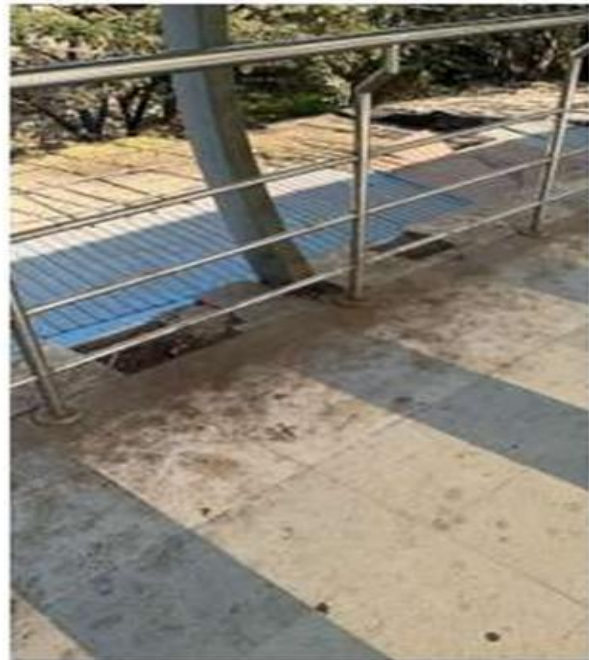
PIER 7 TO PIER 8: -

(VIEW OF PIER, DECK SLAB, FLOOR)

1. Pier 8- Surface corrosion detected, cleaning required
2. Flooring damaged. cleaning required.

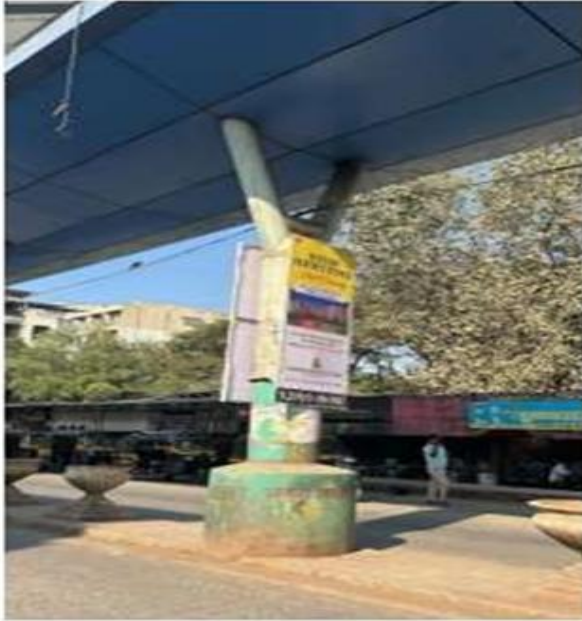
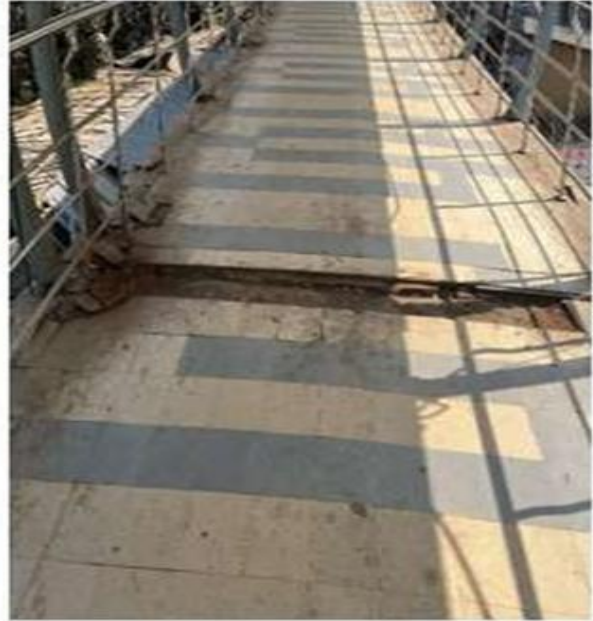
PIER 8 TO PIER 9: -

(VIEW OF PIER, DECK SLAB, FLOOR)

1. Pier 9- Surface corrosion detected, cleaning required
2. Flooring damaged. cleaning required.

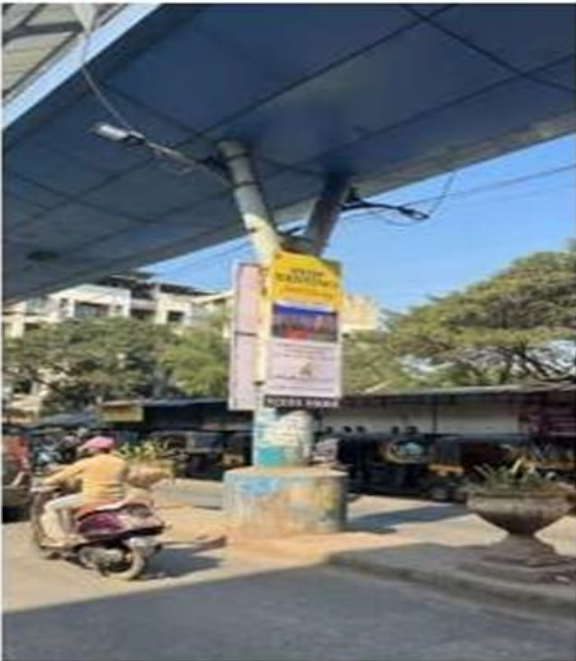
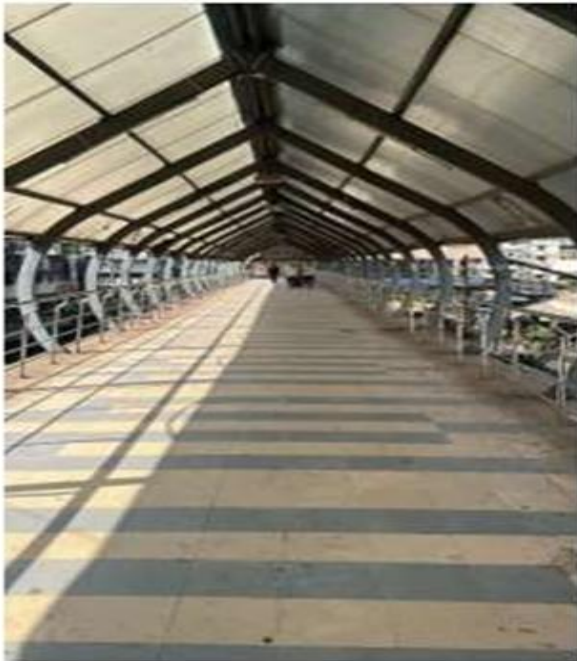
PIER 9 TO PIER 10: -

(VIEW OF PIER, DECK SLAB, FLOOR, ROOF)

1. Pier 10- Surface corrosion detected, cleaning required
2. Cleaning required.

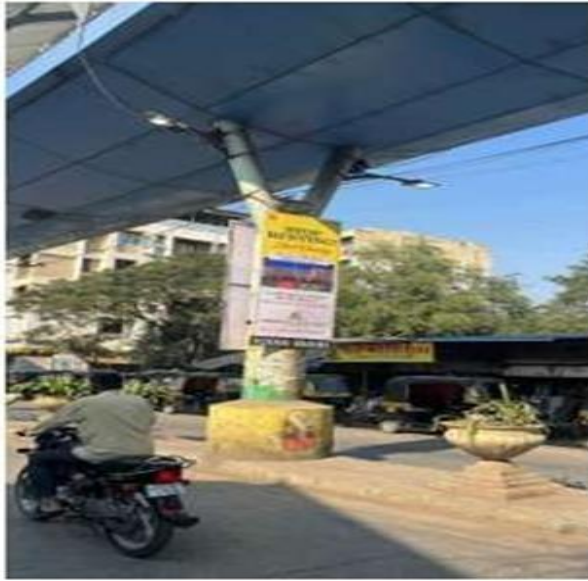
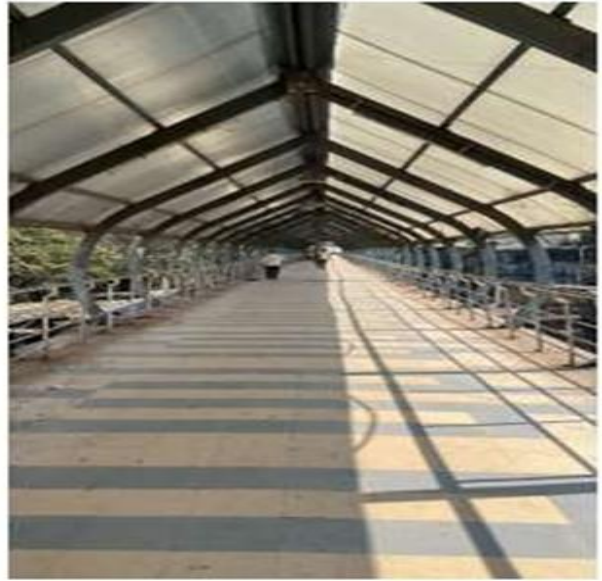
PIER 10 TO PIER 11: -

(VIEW OF PIER, DECK SLAB, FLOOR, ROOF)

1. Pier 11- Surface corrosion detected, cleaning required.  
Cleaning required.

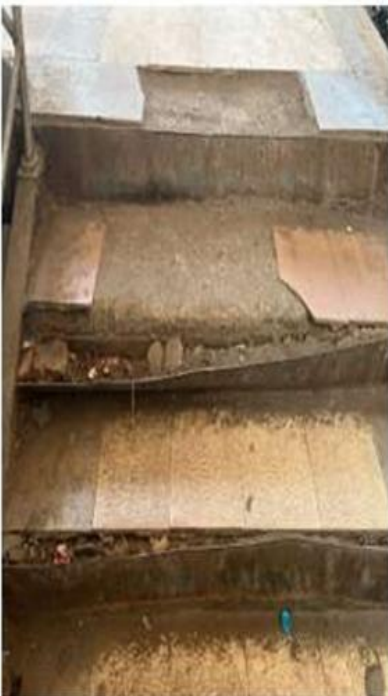
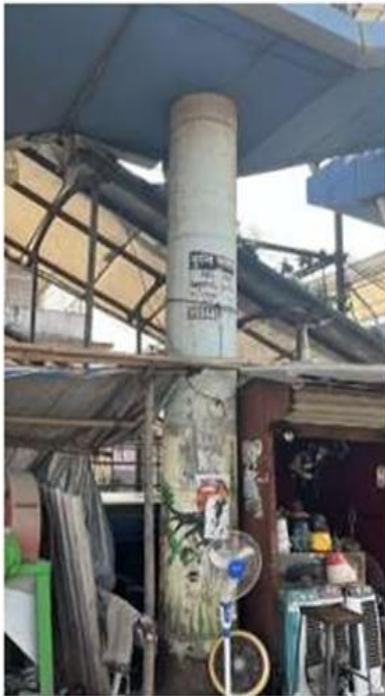
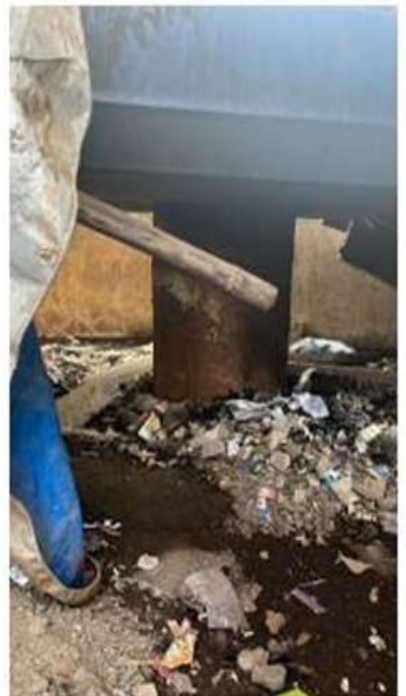
STAIRCASE 2: -

(VIEW OF STAIRCASE)

1. Flooring tiles damaged majorly.
2. Uneven tread and riser.

5. The flooring, particularly at the staircase areas, is damaged and requires repair.
6. The protective wall of the column is damaged at certain locations and requires necessary repairs (refer to the drawing).
