Unforeseen ground conditions met in North Bound Tunnel (TBM - Rudra) in Tunnelling Work and solution found, Remedial measures Implemented – Case study

RUPA PARAMANIK BANERJEE¹, PROF DR. SANDEEP POTNIS², SUBRAHMANYA GUDGE³

³ Bangalore Metro Rail Corporation Ltd. Bengaluru, India

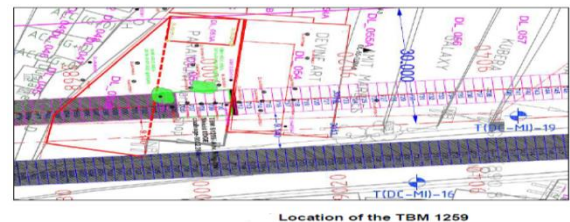
Fig. 1: Showing location of TBM 1259 of of North bound between Dairy circle to Lakkasandra stretch from CH.9000 to CH.9050

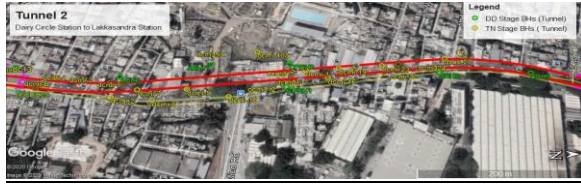
Fig. 2: Showing the google earth view of RT01 Tunnel alignment (Drive 2) North bound between Dairy circle to LAKKASANDRA STRETCH

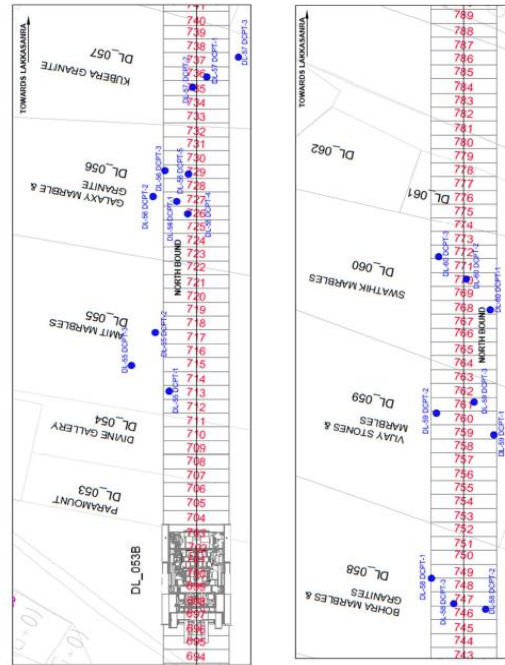
DCPT Points location:

Fig. 18: Showing locations of DCPT points

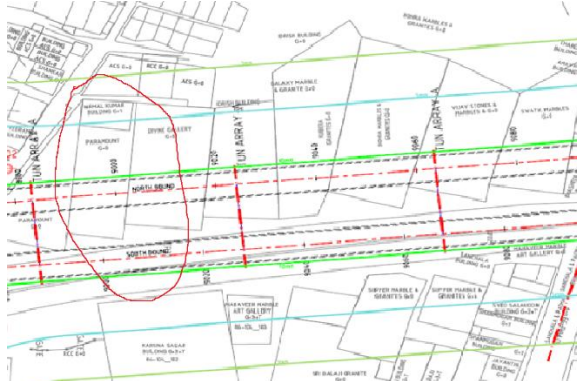
INSTRUMENTATION AND MONITORING DATA RECORDING AT SITE

BSM and some of the instruments were damaged due to sink holes. Refer Annexure D for details.

Fig. 19: Showing Instrumentation and monitoring array at the location

Table 6: Showing BSM instrument and monitoring data at site and few instrument damaged due to sink hole
