A Study on the Shrinkage Control of Concrete Using Synthetic Fibers (Early age shrinkage control Module 1)

Suyash Khatavkar¹, Prof. M. S. Kakamare²

^{1,2}Dept. of Civil (Structural Engg.), PVPIT Budhgaon, Sangli- India

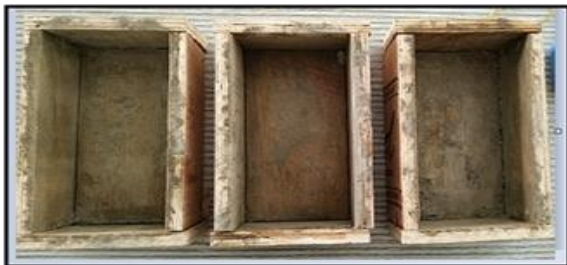
Fig. 3- Specimen Mould

The slab mould of dimension 60x100x200 mm were used which were made of laminated sheet boards. Before placing of concrete to remove the base friction between concrete and surface of laminated board a thin polyethylene sheet can be used. To provide additional restraint and to avoid longitudinal movement of the concrete from the edge's nails have been used at the ends.

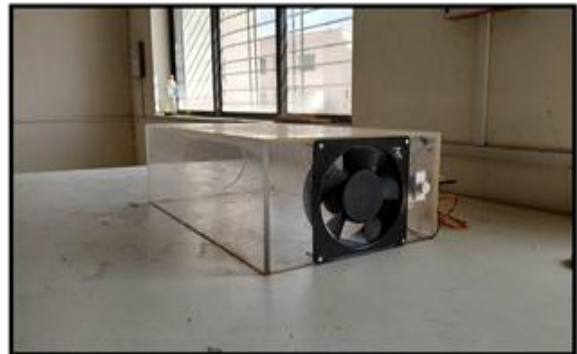
Fig. 4 - Environmental Chamber

The test phenomenon has been performed during a short period of time i.e. 24h in order to check the cracking related problems in the early age shrinkage. The specimen mould were placed in an environmental chamber having dimensions of 175x350x550 mm as shown in fig. To accelerate the drying of concrete a high-speed fan with regulator is used which is fixed on the walls of the chamber. The fan also controls the temperature and humidity in between the chamber.

After casting and finishing of moulds the surface was exposed to environmental conditions such as, relative humidity of $50 \pm 2\%$, high wind speed of 3.9 m/s and a temperature between $33 \pm 1\text{°C}$ in order to satisfy shrinkage and crack formation phenomena

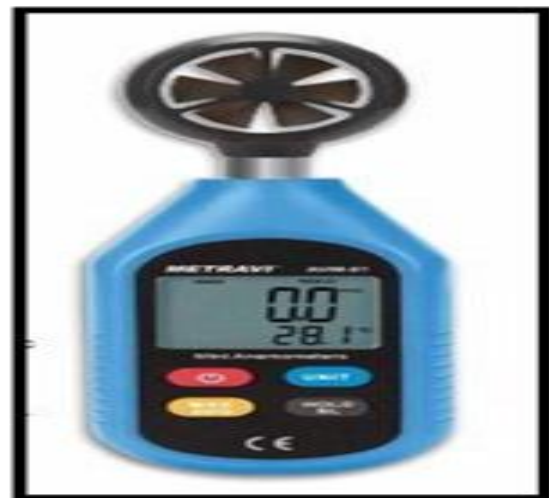
Fig. 5 - Anemometer

An anemometer is an instrument which measures speed of wind, temperature and wind pressure which is used to measure above mentioned parameters when the samples were in environmental chamber.

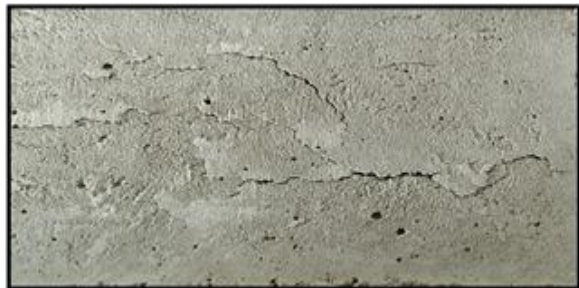
Fig. 7 – Crack Observation

In case of plain cement concrete, around one hundred and sixty min (160 min) after mixing with water, a fine hairline crack running throughout the width of block was determined above the central stress riser. This fine crack, that might have presumably been caused due to settlement, was found to widen upon further drying with in the case of fiber reinforced concrete specimens.

In case of plain cement concrete, a fine hairline crack was found. However, for fiber concretes no cracks were found.

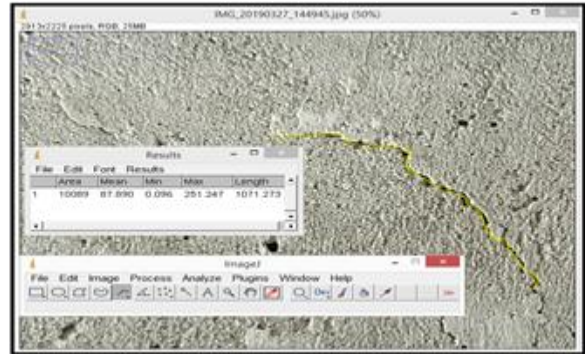
Fig. 8 – Crack Observation

The measurements of cracks include of the length, width of crack (max. & avg.) and area of total cracks. For the measurements of cracks images were captured using an optimal zoom camera based on crack visibility, after that image analysis software has been used for processing and editing of captured images to have a clear crack profile using different keys, commands and operations. Below an example is given of an image after the actions taken and operations in Fig. 8.

For the better understanding of the development of cracks and the microstructure of the cement based systems Image Analysis software has been used. Using curve tracing tool, the length of crack was determined in the image analysis software to trace the crack then in terms of pixels the length was calculated, after that converted to length units (mm) using the calibration scale.

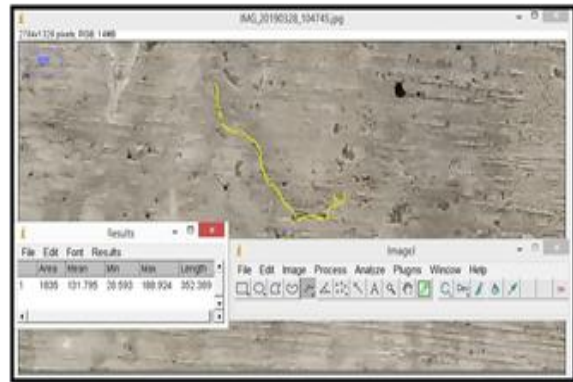
Fig. 8 – Plain Concrete Specimen

Experimental results show that the cracks having maximum width were observed on plain cement concrete Specimen and no cracks were observed on the fiber added specimen. The overall cracking phenomenon were reduced with addition of synthetic fibers. The test results of the proposed work are described as follows in two contexts mainly AR-Glass Fiber and Polypropylene.

Sr. No.	Type	Crack Width	Crack Length	Crack Area
1	Plain Concrete	28.59-188.92	352.389	1835
2	AR- Glass Fiber Reinforced	-	-	-
3	Polypropylene Fiber Reinforced	-	-	-
